Re: Mold and water dripping in attic

From: Marko E. Vovk
Forensic Moisture Investigator
Ambassador Construction Consultants Inc.
1501 Spring Garden
Lakewood, Ohio 44107
Civil Engineer / ASHI Certified Professional Home Inspector / 203K Certified / State
Licensed Radon Inspector / State Licensed Lead Assessor / State Licensed Termite
Inspector / State Licensed Termite inspector / Certified Indoor Environmentalist /
Certified Air Balancer / Structural Inspector / Over 7000 Home Inspections Performed /
Over 750 Environmental
Inspections performed / Over 1000 Microbial or other samples taken.
216-431- TEST (8378) Voice mail and downtown office
216-924-TEST (8378) Car
216-421-0790 Home fax
Clevelandmold@AOL.Com
www.houseinvestigations.com

Date: 2-15-04 Cold Snow Cover / 22.8 F / 46.4 RH / Dew point 7.5
Inspection time 11:30 PM – 1:30 PM

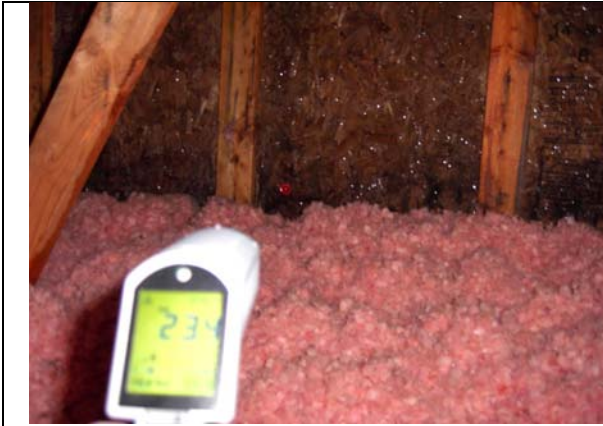
Attic sheathing and timbers were saturated at the time of inspection.

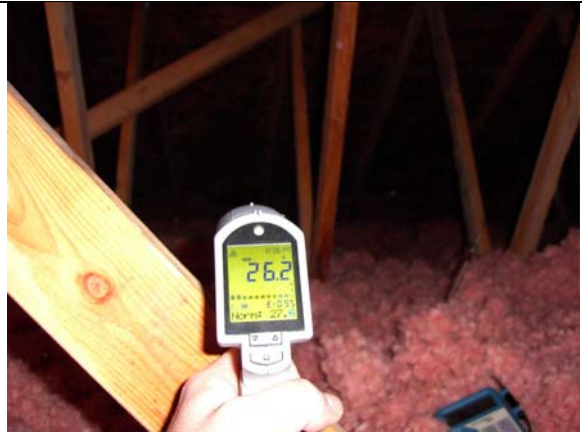
the infrared temperature instruments show the low temperatures in the attic.

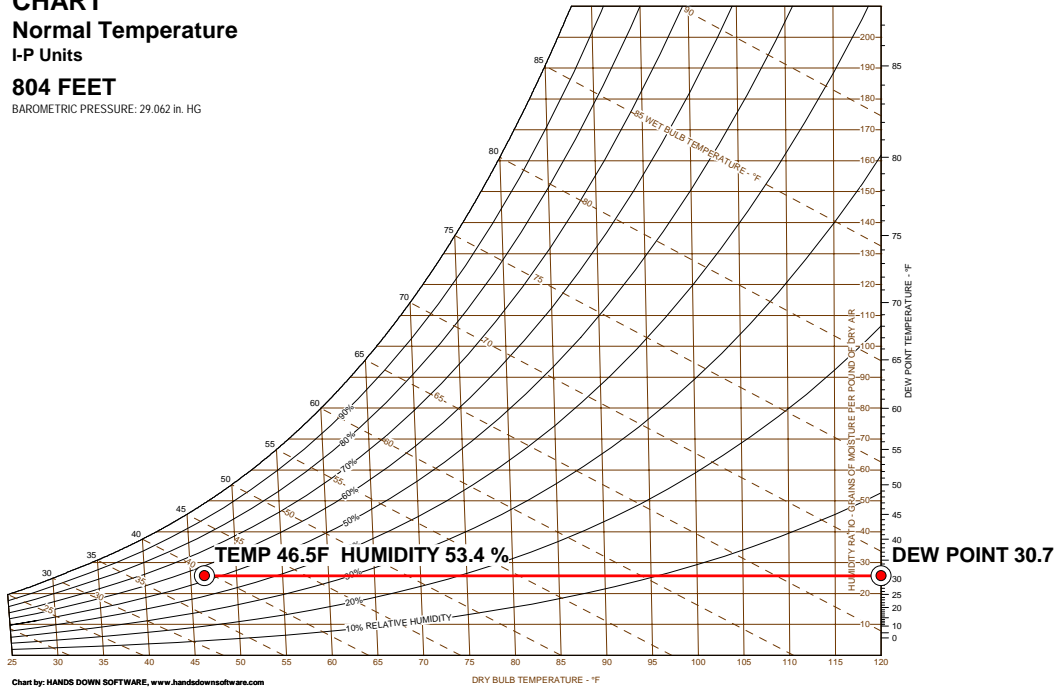
ATTIC MOISTURE CONDITIONS

THE CALCULATED DUE POINT IN THE ATTIC WAS FOUND TO BE 30.7 F. Most attic surfaces were at or below the dew point. Condensation was severe and much of the insulation was wet.

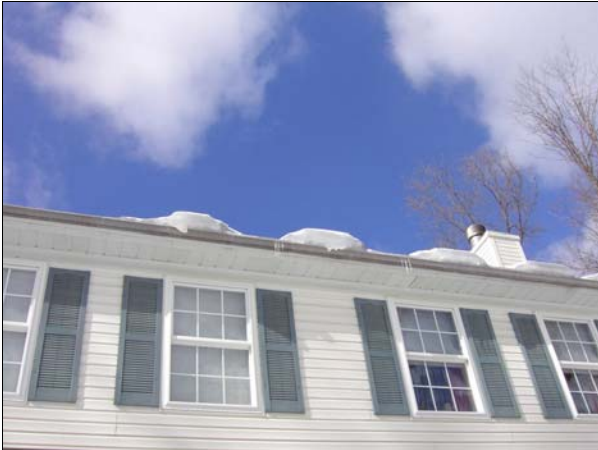
Ice dams are active and are being caused by inadequate soffit venting.

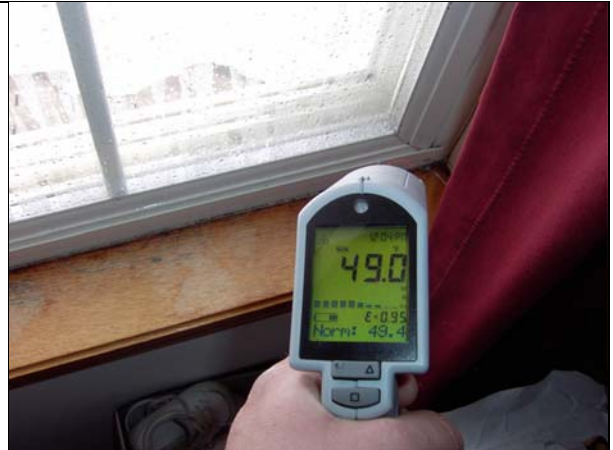
Dew points are forming on windows and wood causing fungal reservoirs to develop.

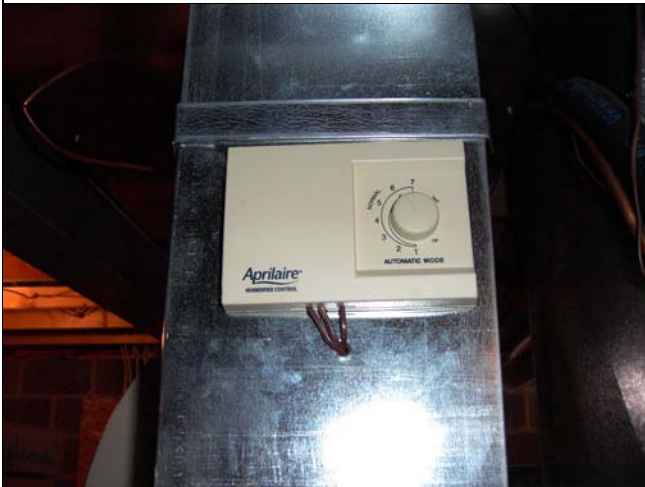
The furnace company set the humidifier on to high and did not warn the homeowner of potential outcomes. Due to this condition, the home became contaminated with fungal spores.

- 1. You must lower the humidity in this home. Shut down the humidifier on the furnace and seal up the sump pump pit.**
- 2. Install a basement dehumidifier.**
- 3. Alter living habits slightly, to help diminish the high level of indoor humidity.**
- 4. Monitor the humidity and monitor further development.**
- 5. Make sure all soffit and ridge vents are effective.**
- 6. Remove all wet insulation and investigate the ceiling drywall for fungal reservoirs.**
- 7. Employ a mold professional to remove fungal reservoirs and damaged sheathing.**
- 8. It is very possible that the nails will start popping through the roof membrane and through drywall as you dry the home. A substantial amount of collateral damage may exist.**

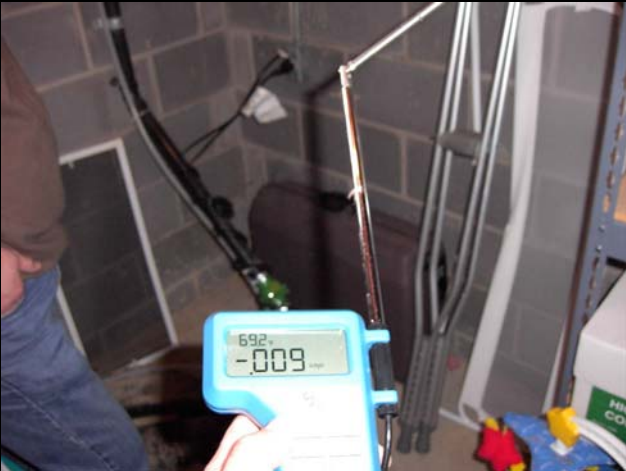
The VelociCalc Plus shows that the basement is slightly depressurized. The heating system was not properly balanced during construction. If it were balanced, the builder would have provided the HVAC balance calculations and data.

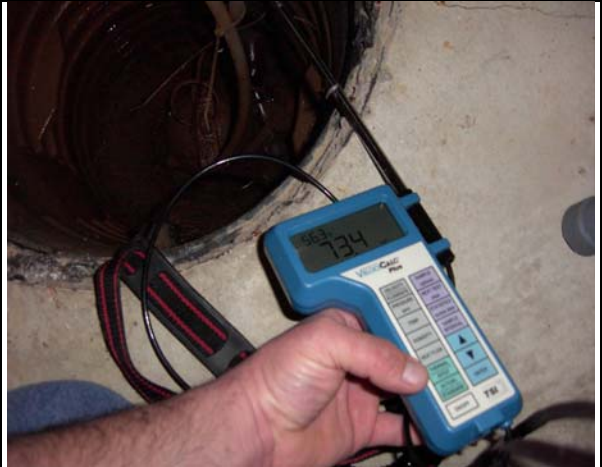
The VelociCalc Plus was used to traverse the drain tile that terminates into this sump pump pit. The following readings were obtained:
145,144,151,150,139,172,130,144,165,163,160,146, and 90 CFM.

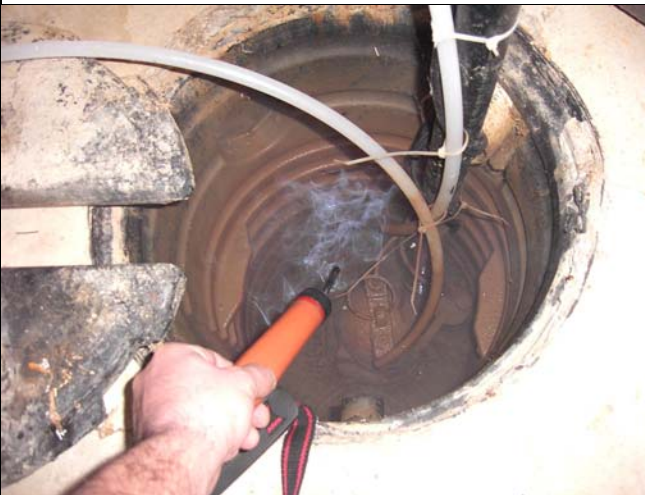
Smoke testing also showed that this sump pump is sucking moist latent air from the drain tile. The smoke is not being sucked into the drain-tile. The smoke is being pushed out.

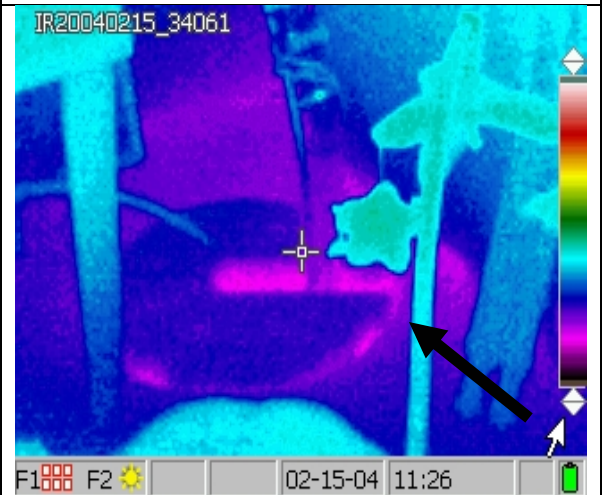
The infrared image also shows the colder moist air leaving the sump pump pit. The temperature of this air was 50 F and the relative humidity was 75.6%. See the purple color; this is the cooler moist air being sucked out of the sump pump pit.

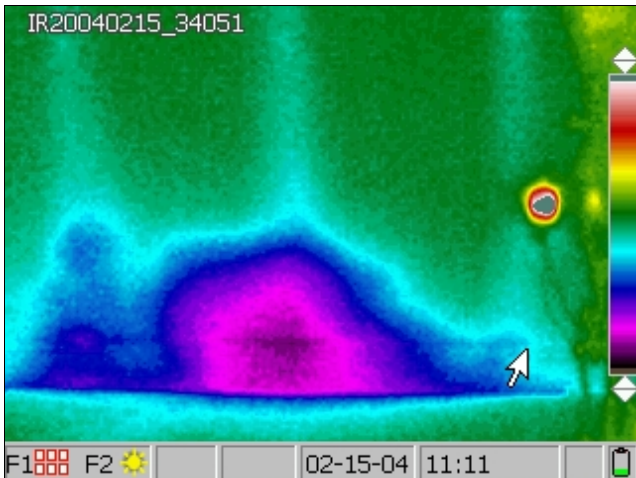
We found a cold spot in the north wall that could be missing insulation or interstitial condensation.

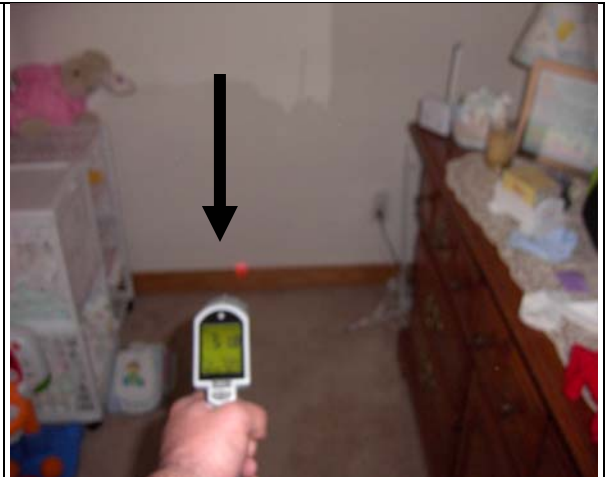
This is an infrared temperature test of the cold spot seen in the infrared image.

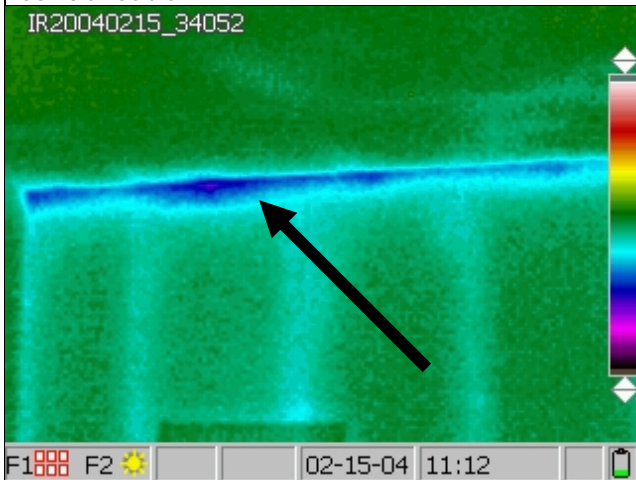
The blue is condensation and wetness on the north wall. The north wall was wet and saturated in the attic from the dew point being reached.

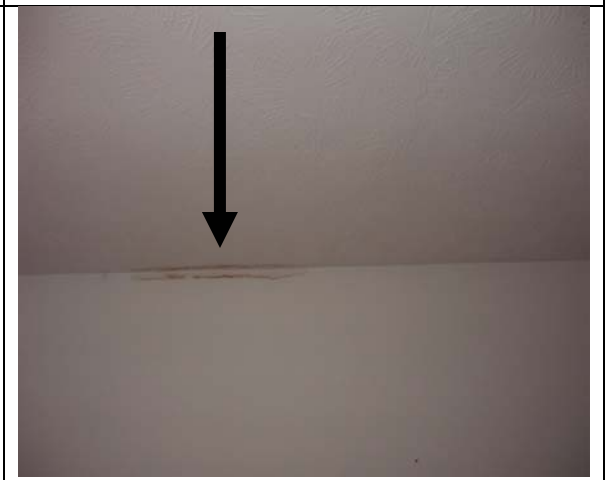
This moisture stain was caused by the attic condensation. The attic is so wet the moisture is starting to come through the ceiling.
