To: Re: Mold and moisture in the attic

**Diagnostic evaluation of why the insulation was wet in the attic area and why fungal reservoirs existed at eaves.**

## Attic condition at time of inspection

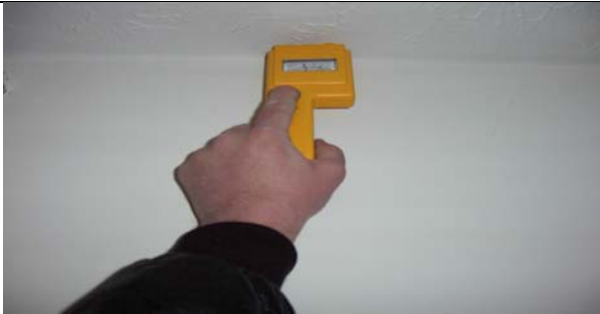
Ceiling has started to dry out on the second floor bedroom.

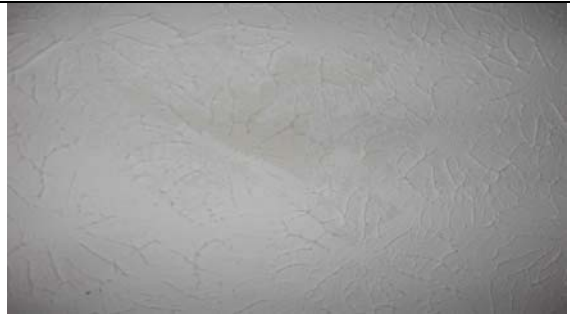
Loose ceiling section in the bedroom on the second floor.

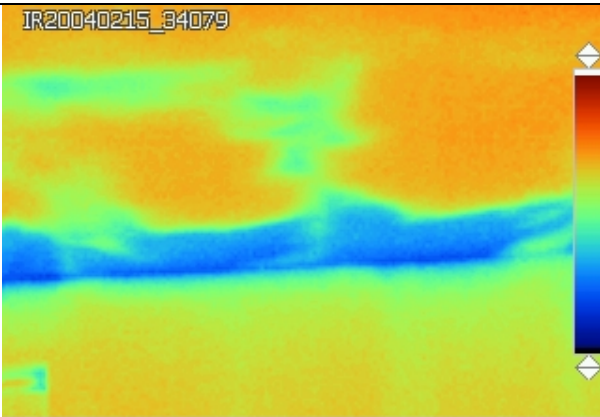
Second floor bedroom ceiling shows past leakage conditions. See the blue color.

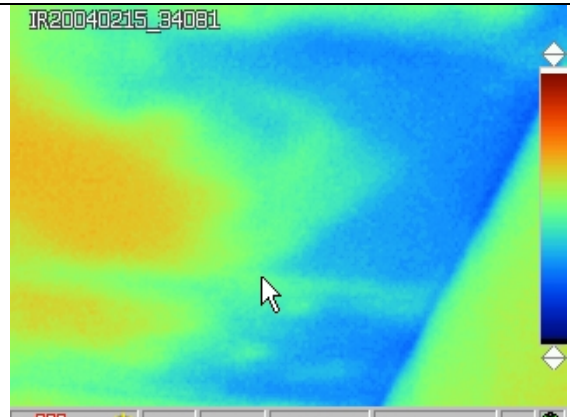
Some moisture still exists in the soffit of the east second floor master bedroom. See the blue color.

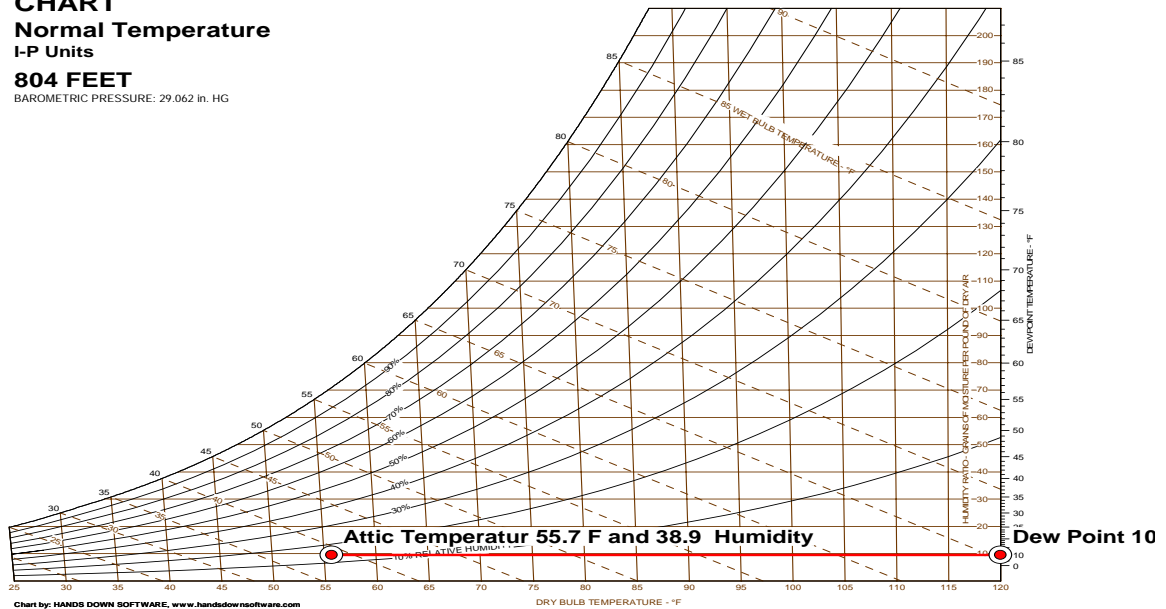
During the time of inspection, the dew point needed in the attic to cause condensation, would need to be 10 F or less. At the time of inspection, a dew point was not being reached. The prior weeks had colder temperatures and the dew point **may** have been reached. We were informed that this home also had ice dams. During the last melt, ice dam back up could have caused have this problem. The upper infrared images were taken at the same location that these supposed ice dams occurred. We were informed by the homeowner that this same location had insulation stuffed into the soffit area constricting lower ventilation needs. If insulation is stuffed in the soffit, the lower ventilation is constrained and could cause ice dams.

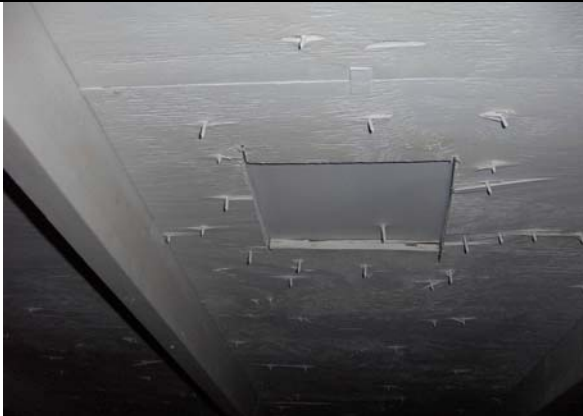
It appears that the last roofer covered the top hats or roof vents. It appears that a ridge vent was added. The soffit was not checked and the insulation was not removed. Roofers who install ridge vents should make sure the

adequate soffit venting exists. We were informed by the homeowner that soffit ends had insulation.

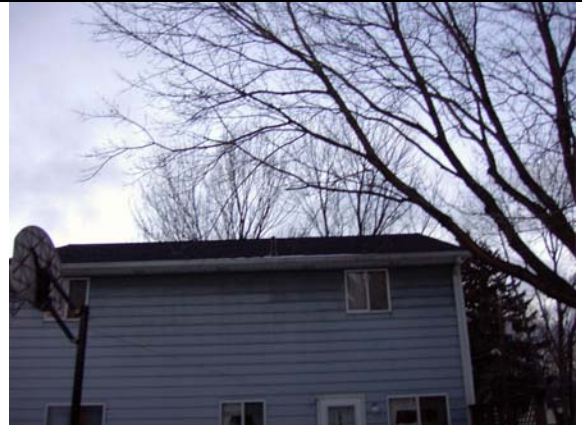
Some snow and ice still existed in the gutter on the east side. Ice dams were caused by heat loss in the attic and cold soffit. If the soffit were stuffed with

insulation, the potential for ice damming would exist.

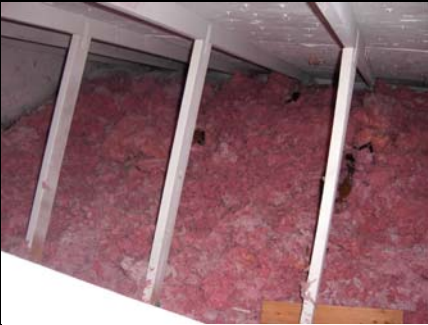
At the time of inspection, the insulation had been removed from the soffit area. Some fungal reservoirs exit at these areas. These

conditions appear to be areas that were not sealed during previous mold encapsulation work.

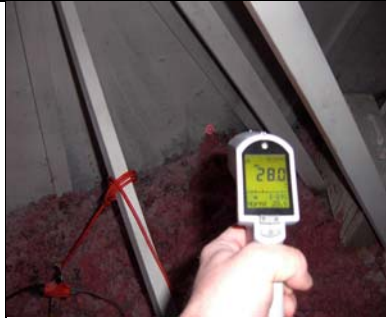
At the time of inspection, the house did not have temperatures that would allow dew points to occur. It is possible the

past cold weather would have allowed for condensation. If moisture accumulated in the attic, fungal reservoirs had the potential to amplify.

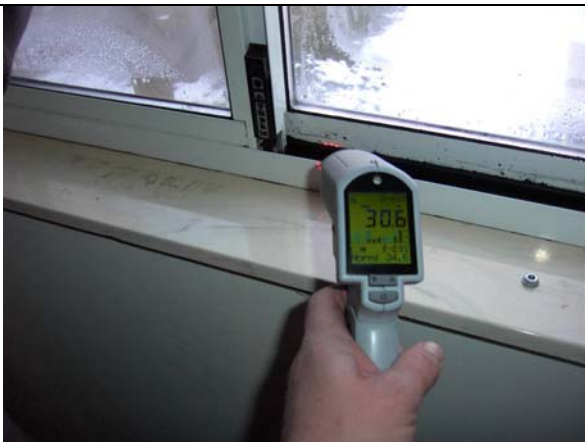
Metal windows are not optimal. They are generally cold and will condensate first. These window show signs of past condensation. At the time of inspection, house humidity levels were low and expectable.

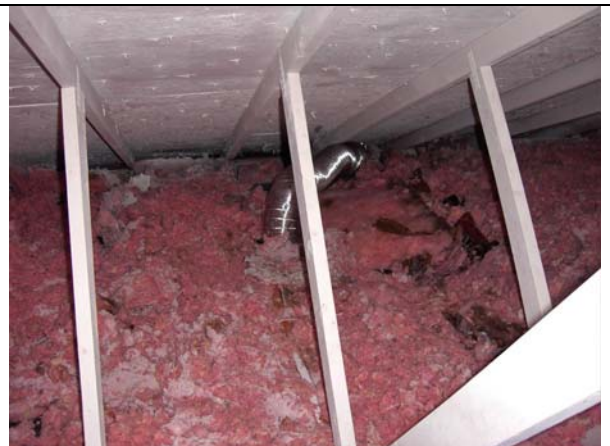
The bathroom vent was sloppy. Bathroom vents should not be constructed. It is my professional opinion, that prior to the recent purchase; this attic had condensation conditions caused by high humidity and form poor soffit ventilation.

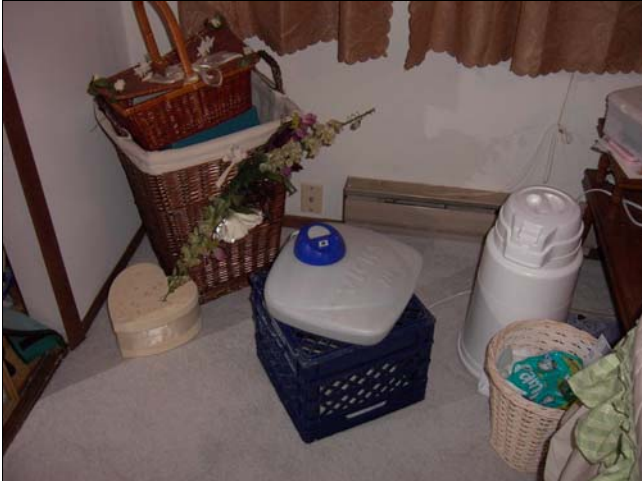
The second floor north bedroom had a humidifier. This apparatus could have easily contributed to augmented humidity levels in the attic.

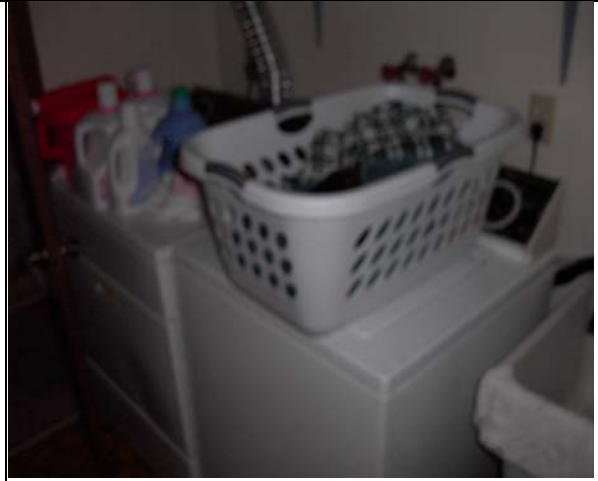
The air volume is not significant in this home. Along with the home being tight, upper levels of indoor humidity could cause adverse conditions.

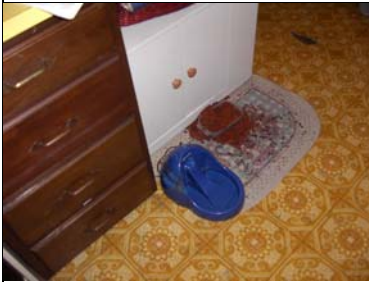
Pets, auto water feeders, plants, cooking, excessive dryer loads, boiling water, and more all contribute to indoor humidity. Although conditions were

considered normal, being cognizant and implement interim controls during cold climates should be done.
