Re: Microbial contamination due to failed building components.
Excessive humidity causing dew points.
Defective HVAC, ductwork, ventilation and other components.

From: Marko E. Vovk
Forensic Moisture Investigator
Ambassador Construction Consultants Inc.
1501 Spring Garden
Lakewood, Ohio 44107

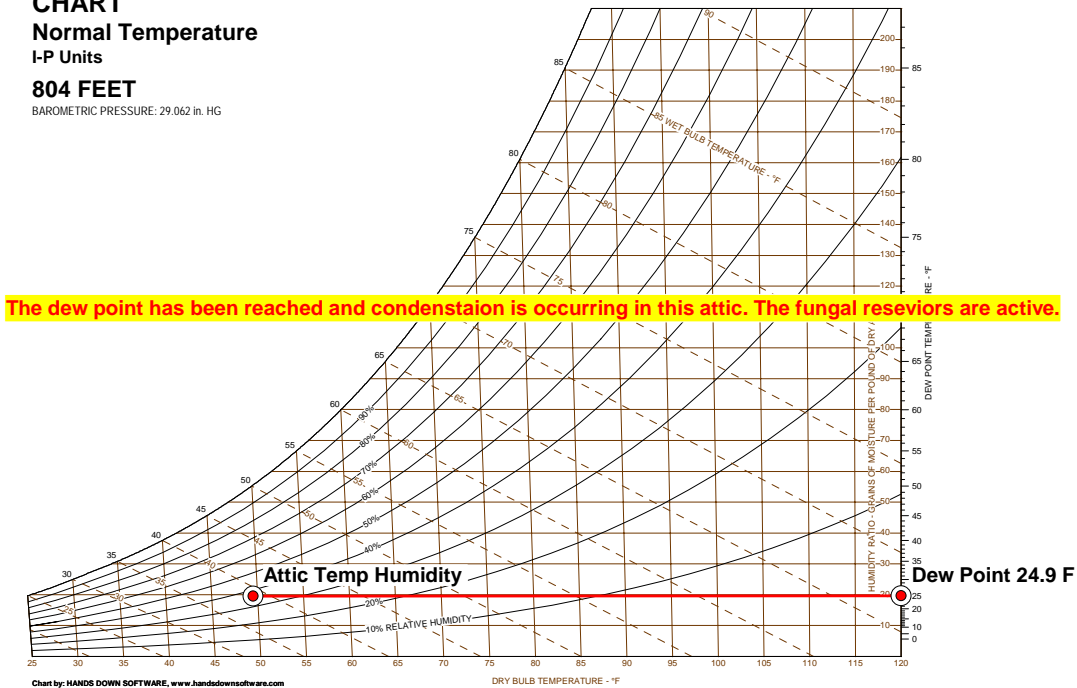
The above mathematical representations depicts that during our inspection, the dew point³ for the above condition was 24.9 F. In conclusion, the entire attic of this home has humidity levels that are causing the dew point to occur. Dew points and moisture are necessary for microbial amplification.

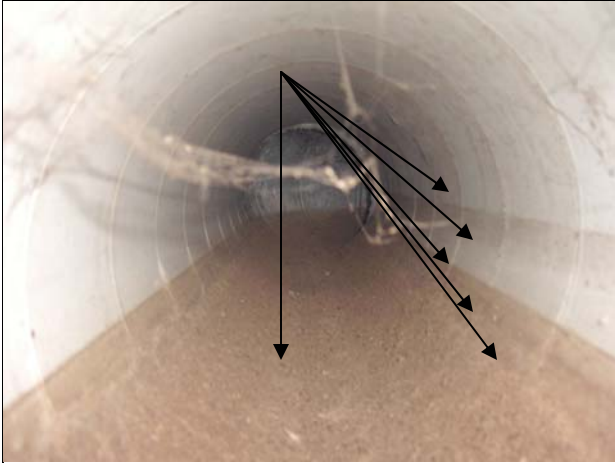
The ducts under the slab have been flooded many times. This can be seen from all the flood marks. For mud to get this thick at the bottom of the duct, flooding must have occurred hundreds of times. Previous owners must have known about this condition. This condition has been occurring for many years and even decades. The exterior drain tile system is defective and allowing sub-slab moisture migration. Due to this condition, damp rise is also suspected.⁵ (5 Damp rise is moisture movement upward through the concrete slab)

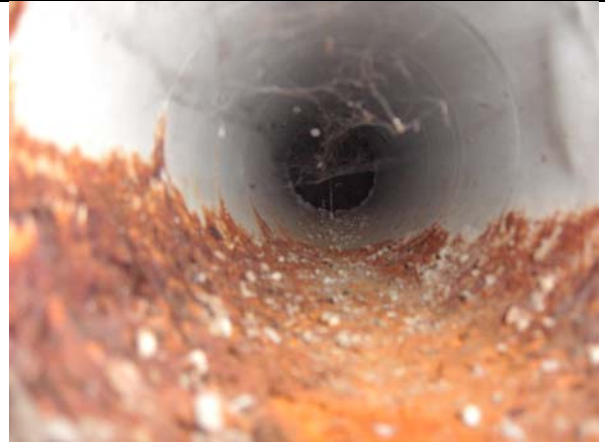
This duct is deteriorated and cannot be cleaned. The least expensive solution may be to fill all ductwork with concrete and install all new ductwork in the ceiling. A new furnace would be needed to perform this task. A feasibility study would be required prior to making duct repairs. Water proofing the entire home and installing exterior sump pumps may also be needed to de-water the entire site to minimize damp rise potential.

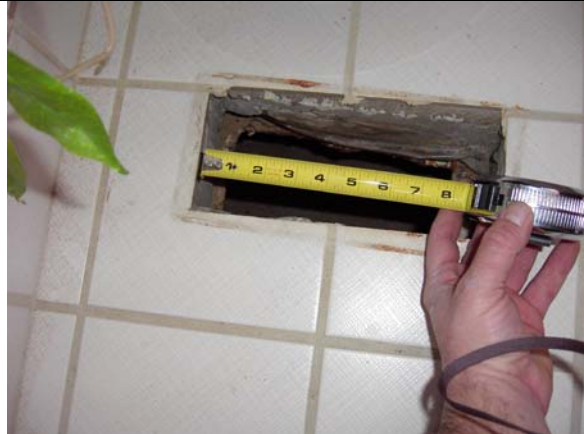
The HVAC installer and builder did not properly compact the soil during the initial construction. The heat ducts settled and large voids exist about the heating ductwork. This is allowing for dust, sand, and moisture to migrate into the dwelling.

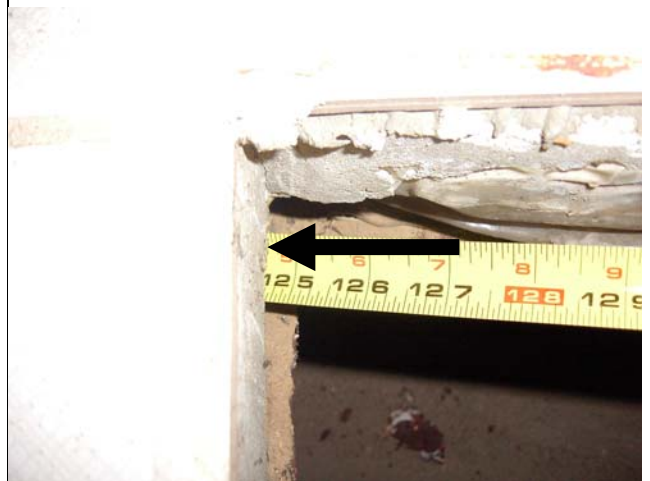
In the duct in the kitchen, I was able to push a tape measure into this void almost 12 foot. The entire dwelling unit is susceptible to moisture, sand, silt, dust, radon fungal, biological contamination. This condition cannot be repaired without slab removal. Ducts under slab should be sealed not to allow contaminants to enter.

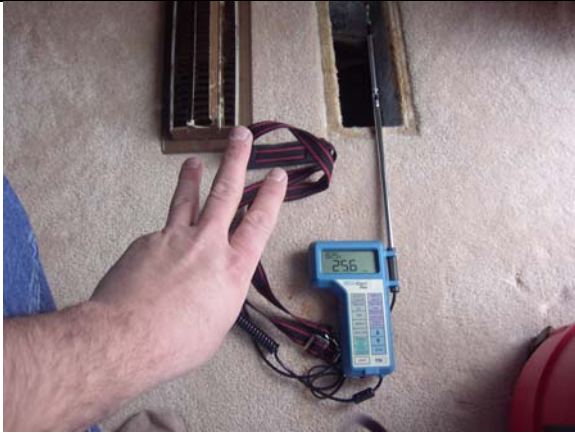
Testing for temperature and humidity was done to ductwork. From the testing results, it was determined the high interior condominium humidity is and has been coming from the subsurface ducts.

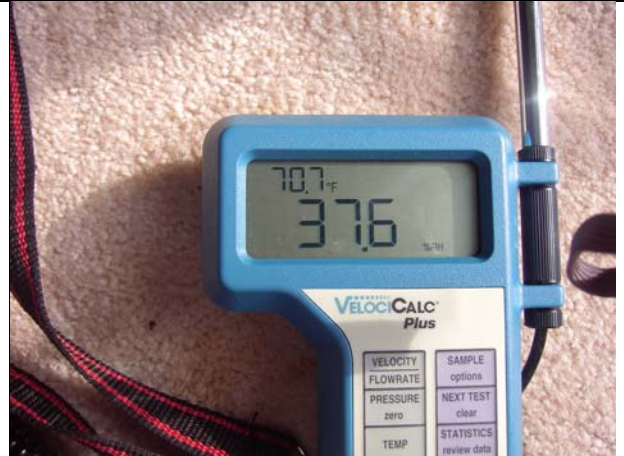
Readings for most indoor humidity, temperature, and dew point was done using a VelociCalc Plus. All readings are documented in the data chart.

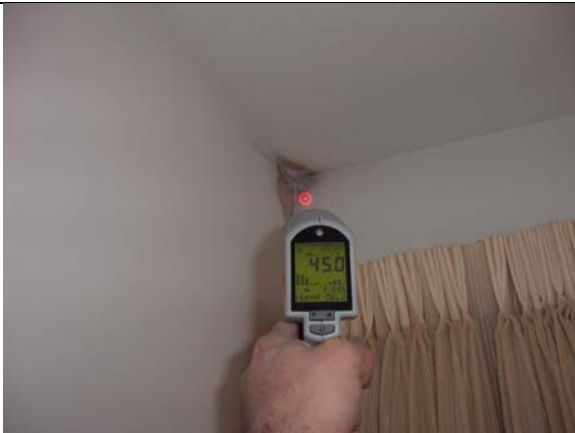
The corners of the home are significantly colder than most other surfaces. In most cases, the corner temperatures were 30 degrees colder. Moisture is condensing at most of these locations allowing for fungal amplification. This is a sign of poor initial construction.

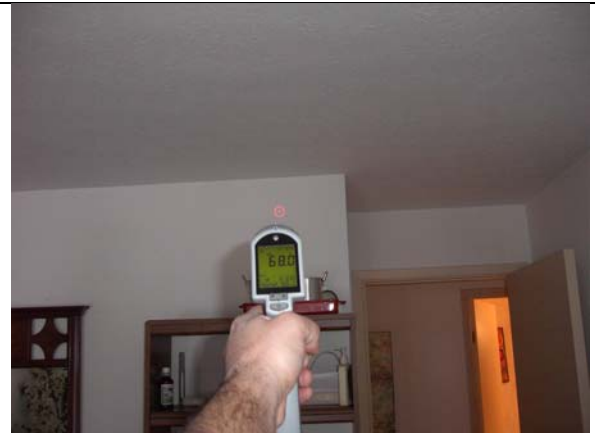
This is a test of an inside wall. The temperature is 68 F. The wall temperature differentials are significant in this home. These area all signs of poor construction, poor insulation, and poor ventilation.

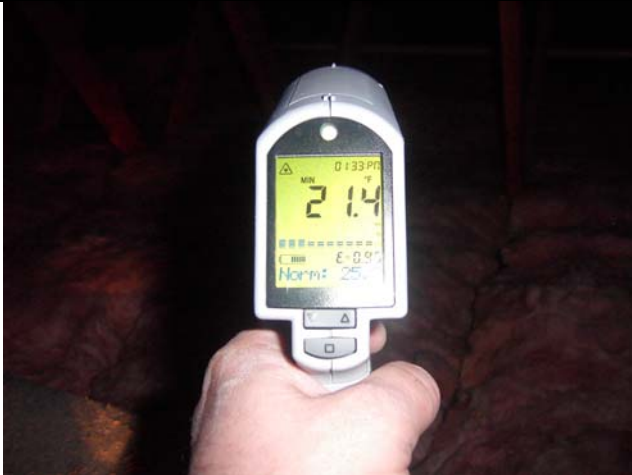
Attic temperature is below the dew point and causing condensation and frost.

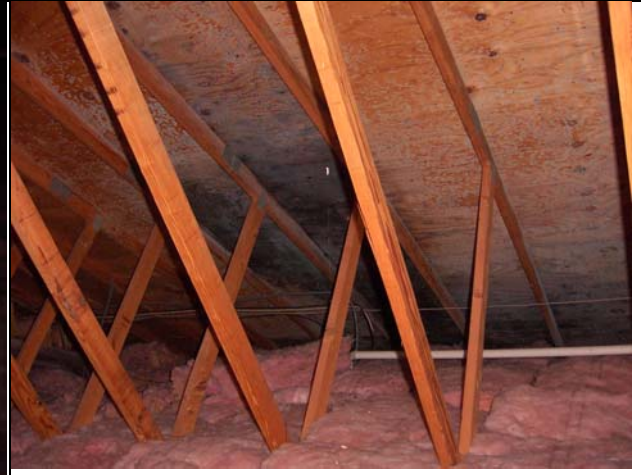
Fungal reservoirs have developed on the attic sheathing because of water in the duct system.

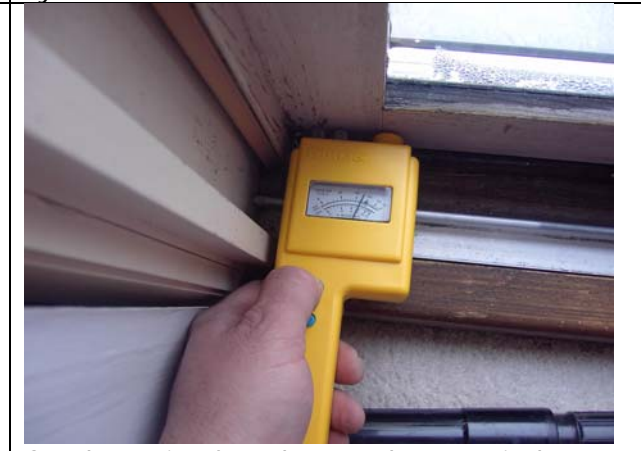
Condensation has damaged most windows on the south side. The average moisture levels were 17% -20%. These levels are excessive and will induce fungal reservoirs and wood decay.

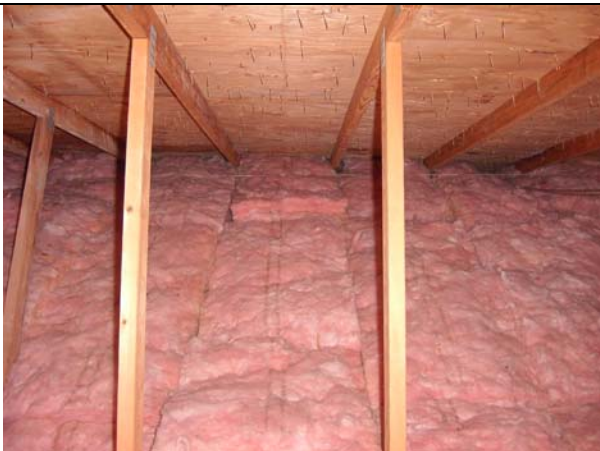
The insulation installation was defective and not allowing for proper attic ventilation.

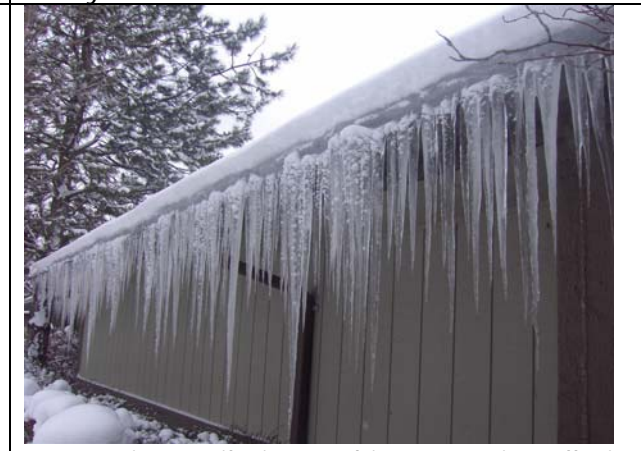
Poor attic ventilation and improper installation are causing excessive ice dams.

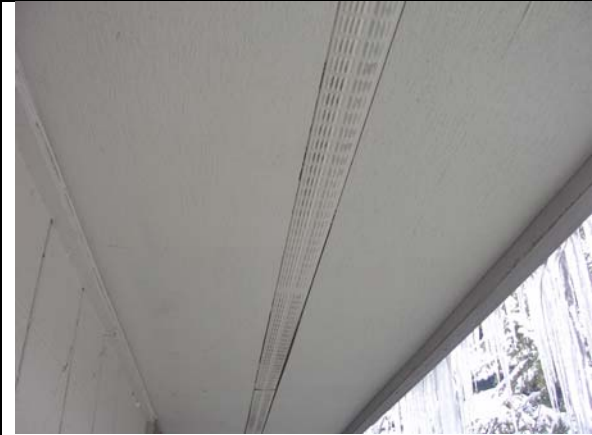
The painter is also responsible for the attic condensation and ice damming. This painter painted over the continuous soffit vents clogging them restricting necessary airflow.

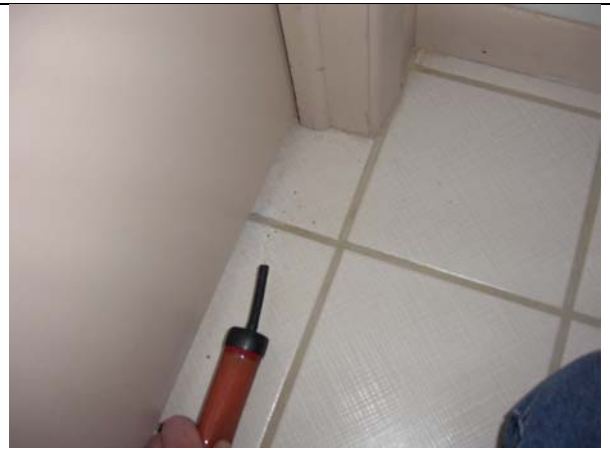
The HVAC is not properly balanced. Some rooms are pressurized and other rooms are depressurized. Depressurized rooms and cause undesirable interstitial conditions.

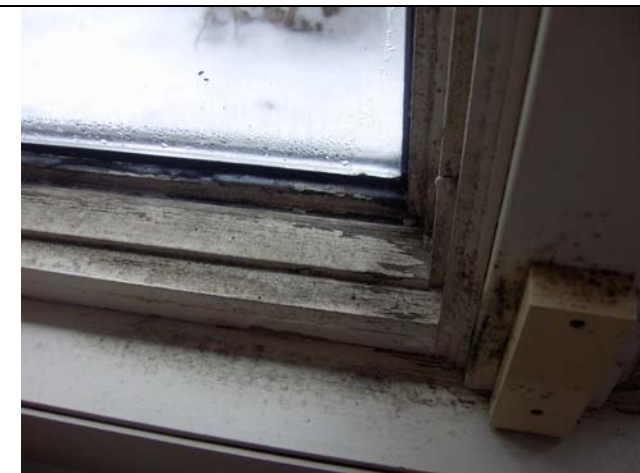
Fungal reservoirs on most windows and under window units. Using a thermo imager can determine cold cavities with potential defects.

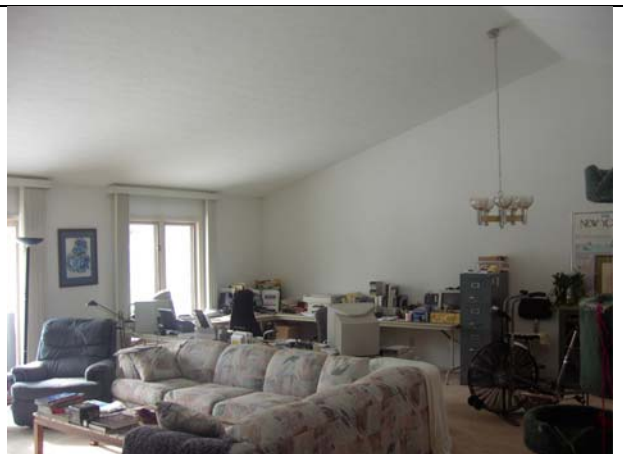
Cathedral locations were not accessible at the inspection time. Conditions at these areas are unknown.

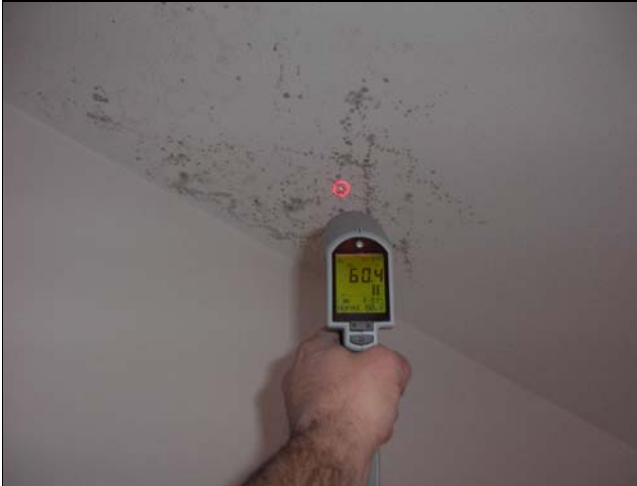
Fungal reservoirs on ceiling at cold areas

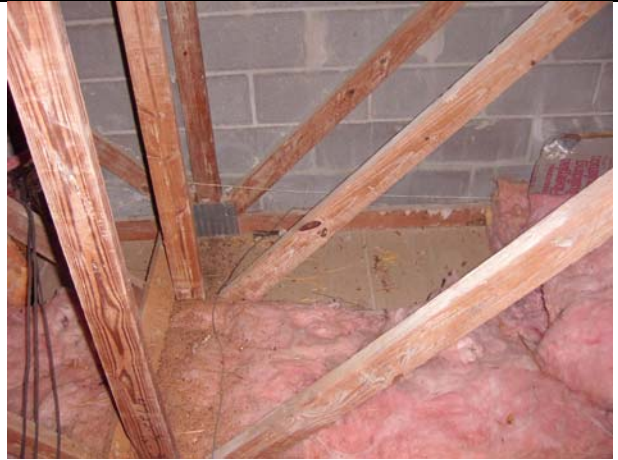
This condition is directly above a fungal reservoir that existed in the adjacent image. Insulation is missing and causing a cold ceiling condition.
