Re: Mold and water dripping in attic

From: Marko E. Vovk  
Forensic Moisture Investigator  
Ambassador Construction Consultants Inc.

Date: 1-28-04 Cold Snow Cover / 24.3 F / 35.9 RH / Dew point 30.0  
Inspection time 12:30 PM – 2:30 PM

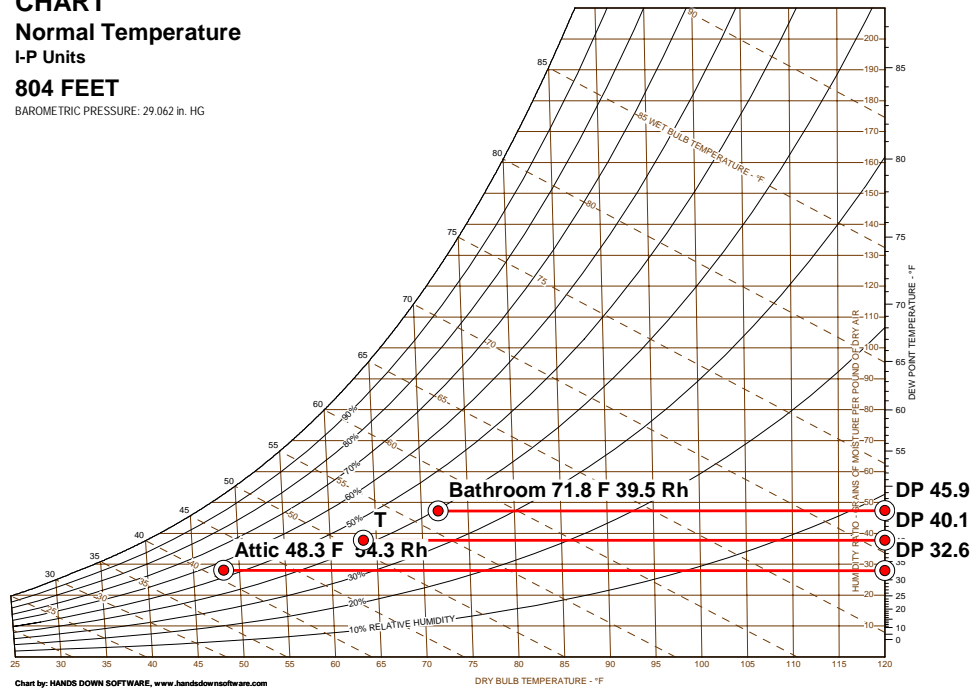
**Wet insulation math above bathroom**

The bathroom below this wet insulation area had indoor air conditions initially at 71.8F room temperature and 39.5 relative humidity. The actual dew point was found to be from the above chart to be 45.9F. We also plotted the attic conditions and

found the dew point to be 32.6 F. This means that that moisture is condensing somewhere between these two dew points. We measured the temperature of the different layers of insulation using an infrared device. The temperature was found to be in this range. This is why the insulation is wet between the first and second layers of insulation above the bathroom. It was inevitable that water accumulated above this bathroom. You should not use two layers of batten insulation because moisture will be trapped. It is a double vapor barrier and moisture will be trapped. Sometimes, if you do not have this vapor barrier moisture can move freely through vapor diffusion and exist. However, in this home, moisture does not completely exit. It stops at the attic sheathing and forms another dew point. All or most attic sheathing was found to be below the calculated 32.6 F dew point. Attic surface temperatures were found to be 31, 36.2, 30.6, and 31.6. This condensation is causing desirable conditions from microbial amplification.

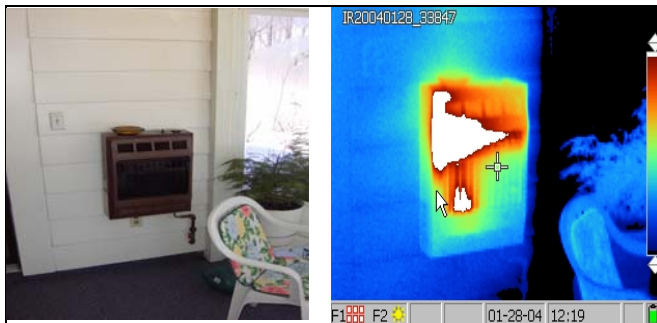
The patio has a ventless heater. The by-product of this is H<sub>2</sub>O and vapor. This unit continually produces humidity when on. The room is used for plants and smoking. Everytime the patio door is opened grains of moisture escape into the dwelling.

- 1. Change ventless heating unit to vented heating unit.**
- 2. Add an indoor dehumidifier to help remove excessive water grains from the air when needed.**
- 3. Abandoned the under slab ducts and relocate.**
- 4. Diminish the amounts of plants.**
- 5. Change life style to diminish excessive indoor moisture accumulation.**
- 6. Fix double vapor barrier problems.**

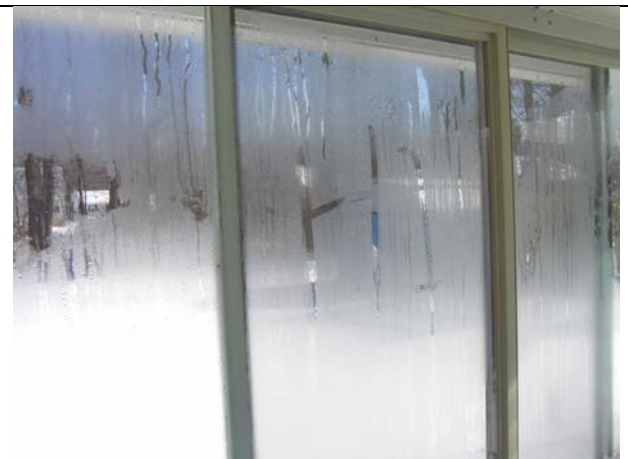
Dew point is forming on the glass in the patio enclosure that has a ventless heater and plants.

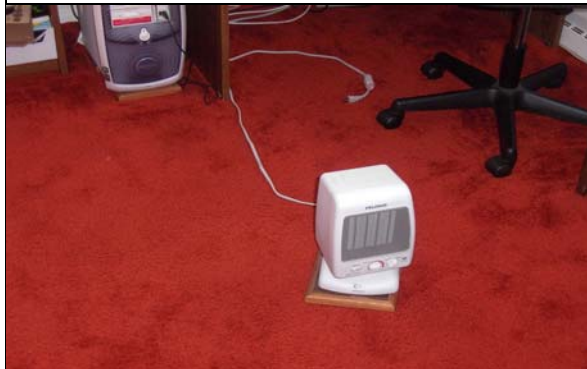
The back bedroom on the south and east corner is the coldest room. The forced air duct located under the slab produces virtually no heat. A problem exists with the sub surface ducts.

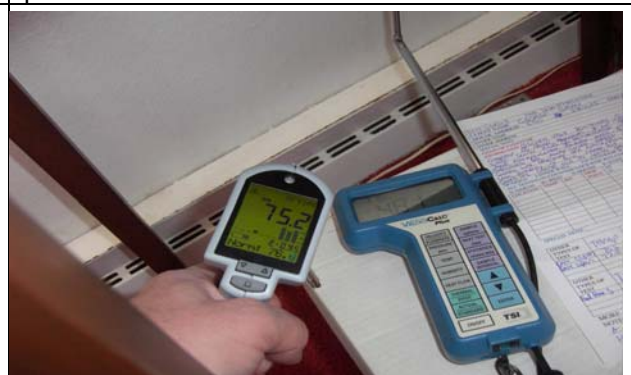
Diagnostics equipment showed the humidity showed that the register was not warm and the home heating system was not properly balanced.

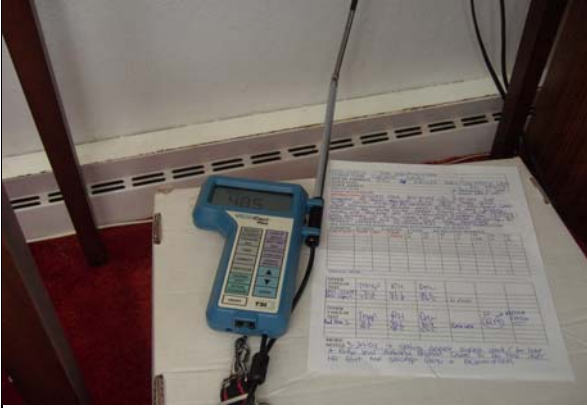
The home humidity was increased after the heating system was energized for one hour. The humidity rose approximately seven percent. This was due to the patio door being opened, moisture from five adults walking around in the small 1200 square foot home, attic access opened, and plants. It was also due from moisture being pulled from the soil from the sub slab ducts.

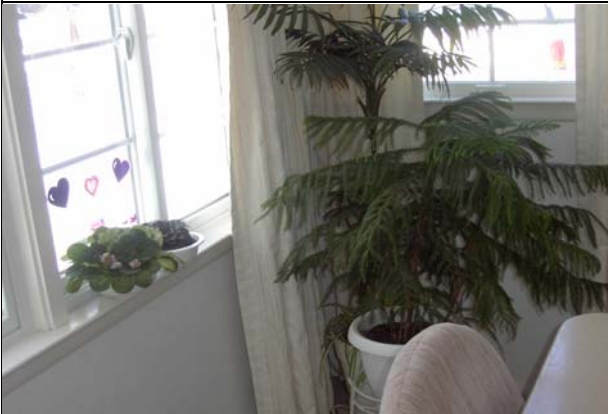
This home had over 20 plants. Each plant must be watered. Most of the water eventually evaporates and contributes to the high humidity. I would estimate the all the plants use about ¾ gallon of water per day. In the winter when cooler air holds less water, it is significant.

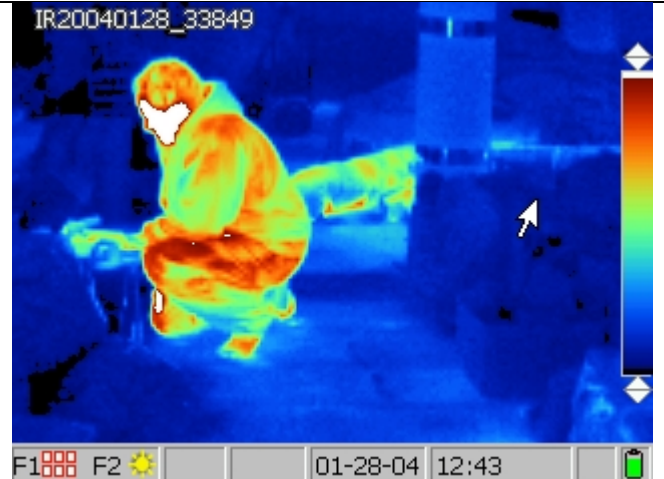
Two people live in this home. People will release moisture as well. Depending on how long people spend in the home will depend on how much moisture is released. Some resource state, that one adult can produce about one gallon of water per 24-hour period.

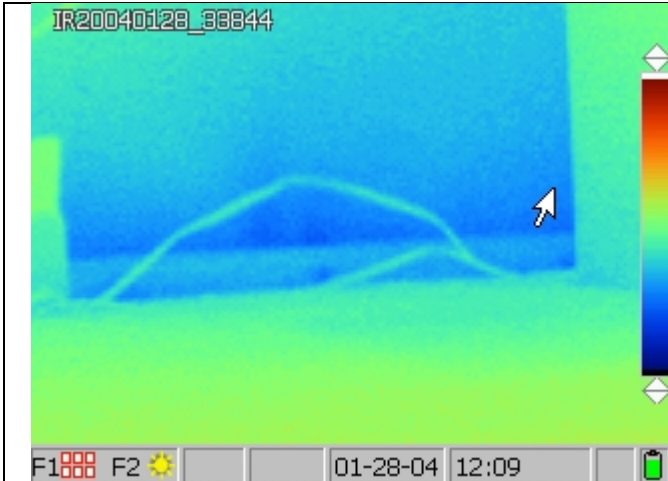
This is a location where fungal reservoirs develop. The adjacent image in the same location with a normal camera. This infrared image shows darker blue colors that portray a cold spot in this home. The temperature at this particular location is approximately six degrees colder than most exterior wall surfaces. This is why fungal reservoirs amplify here first.

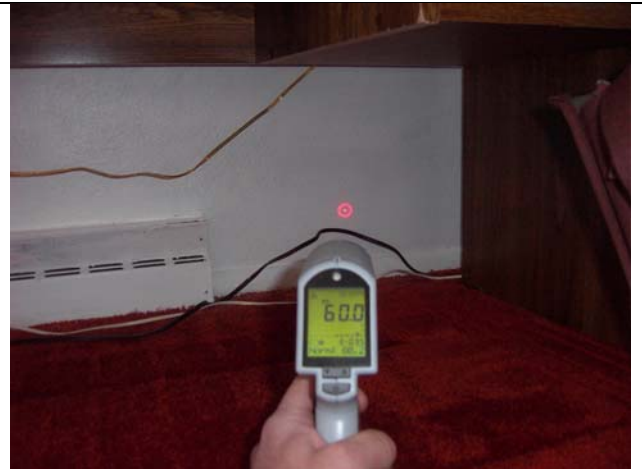
We measured all first floor wall temperatures. The average wall temperature for internal walls was 73F. The average exterior wall temperature of all exterior walls was 66F. If you notice the cold spot from the digital image and infrared image, the temperature is only 60F. It was at this location that fungal reservoirs developed in the past. The east corner was also a location that fungal reservoirs developed. This is in the southeast cold room that also has a poor under-slab duct system. This room reaches dew points much quicker and is more susceptible to fungal amplification. Fungal reservoirs also develop in the attic location above this area due to it being colder.

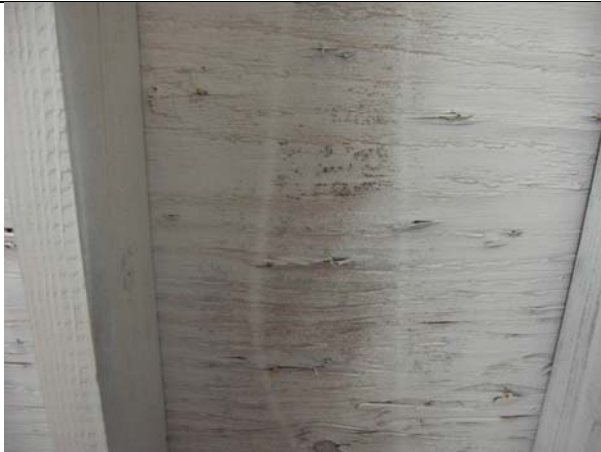
Fungal reservoirs are the result of high indoor humidity. Moisture conditions in this home must be diminished to cease further fungal implication.

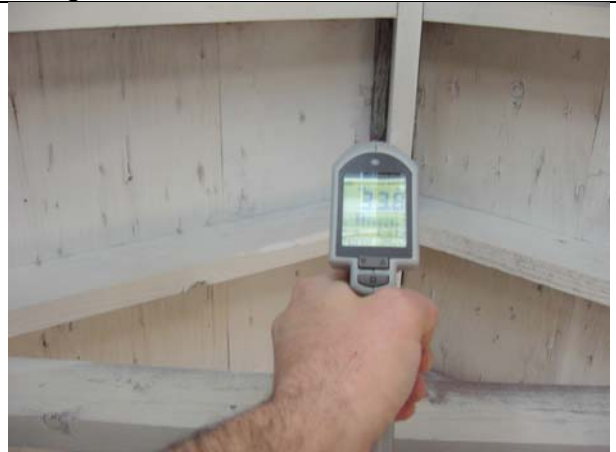
Attic temperatures are below their respected dew points. At the time of inspection, the cobra vent was dripping water to the attic floor.
