Date: 2-14-05

RE: Forensic Moisture Evaluation for Fungal Reservoirs.
1. Building Science Investigation
2. Microbial Investigation with Limited Sampling
3. **Executive summaries on pages 11 and 12**

Building Science Section

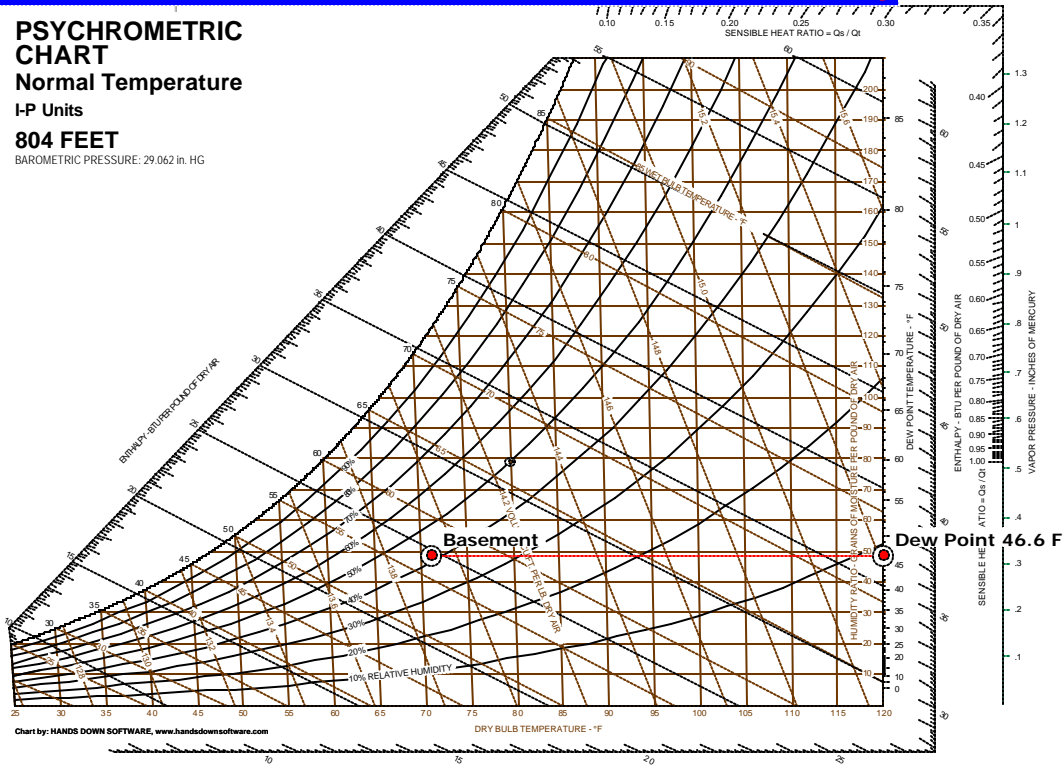
Basement conditions 71.2 F and 41.0 % humidity

The above mathematical representation depicts that during our inspection, the dew point³ for the above attic condition was 46.6 F.

1. With the present basement humidity condition, the foundation wall surface temperatures will fall below this below this dew point and condensation will occur.
2. With the present basement humidity conditions, the band joist pocket temperatures will fall below this below this dew point and condensation will occur.

Dew point temperature and moisture are necessary for microbial amplification. At this time, dew points are allowing for some microbial development. Lowering the homes humidity level is advised and should be done immediately. By lowering the humidity, the fungal reservoir conditions should stop amplifying or slow down the amplification process.

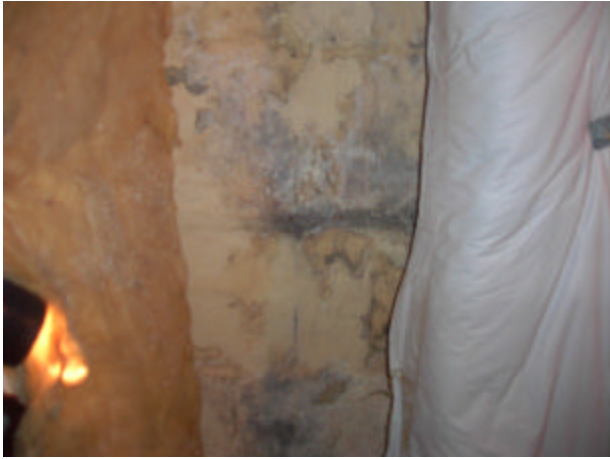
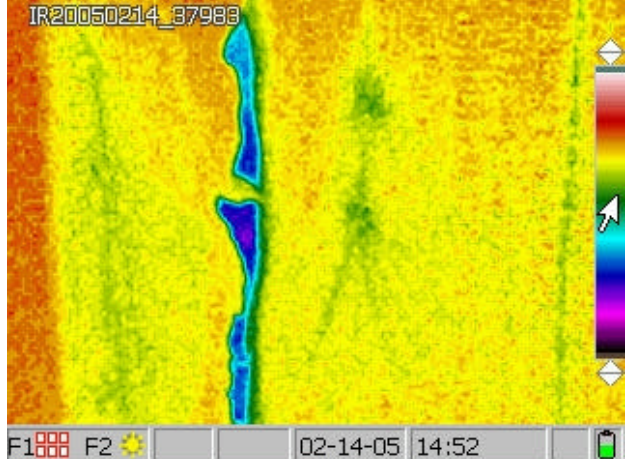
<p>The interior insulation system is not optimal. This insulation system has a vapor barrier. Trapped moisture condensates behind this vapor barrier. Basements in cold weather climates such as OHIO should not have interior basement vapor barriers. If you choose to insulate the basement, it should be done on the exterior.</p>	<p>When walls become wet or damp they must dry. Unlike upper house wall, basement walls can only dry on one side. The exterior of a basement wall is waterproofed and will not dry. The interior basement wall must be able to dry. The present insulation installation, is not allowing for this drying process. The infrared image shows the cold wall behind the insulation.</p>

- 5. Removing the insulation from the upper foundation walls is advised. As stated earlier, this insulation serves as a vapor barrier on a wall that cannot dry. If you choose to insulate the basement, it is recommended doing this on the exterior. The fungal reservoirs can be cleaned and painted.**

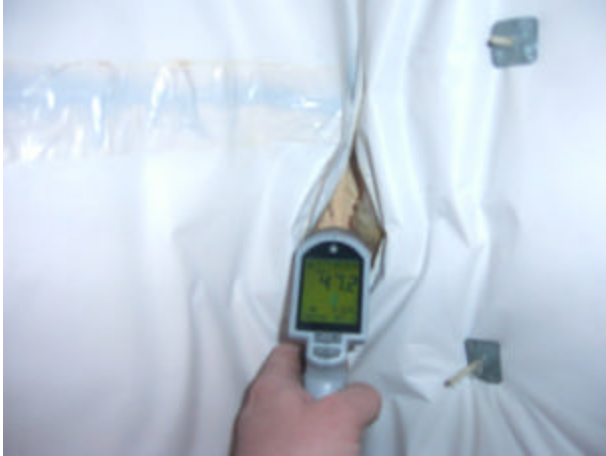
The wall temperatures behind the basement insulation were at or close to their respective dew points. When the dew point is reached, condensation will occur. If you have condensation, fungal reservoirs will amplify.

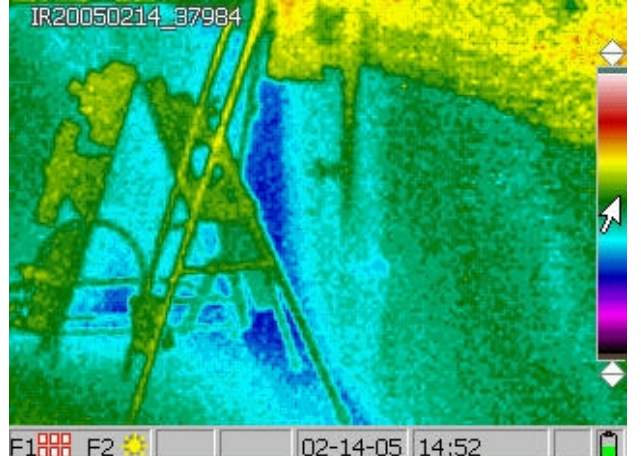
The infrared image shows the cold wall behind the insulation. The basement humidity levels are excessive. If you lower the basement humidity, you will lower the dew point. Buy lowering the dew point you will lower the potential for fungal amplification.

- 6. Removing the insulation from the upper band joist is advised. The fungal reservoirs can be cleaned and painted.**
- 7. Running a basement de-humidifier will remove much of the homes humidity conditions and lower this homes hydrick buffer capacity⁶.**

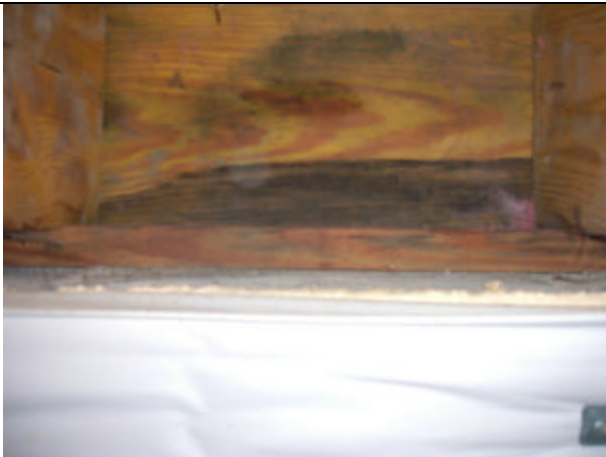
We removed the installation at the band joists. On cold days, this is the coldest part of the home. If the basement humidity high, condensation will occur. Many of these locations had amplifying fungal reservoirs.

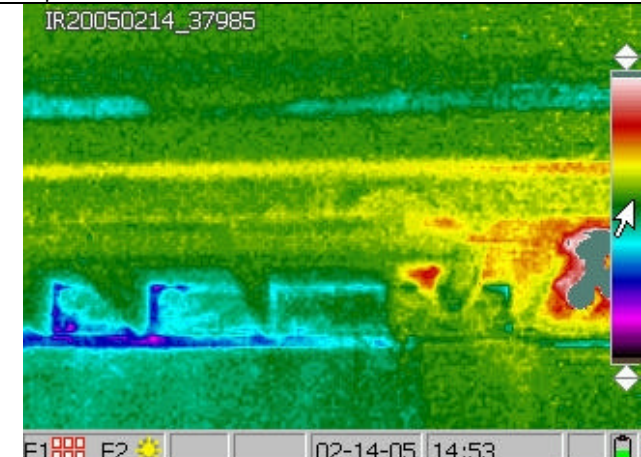
The infrareds image show the cold the upper band joists.

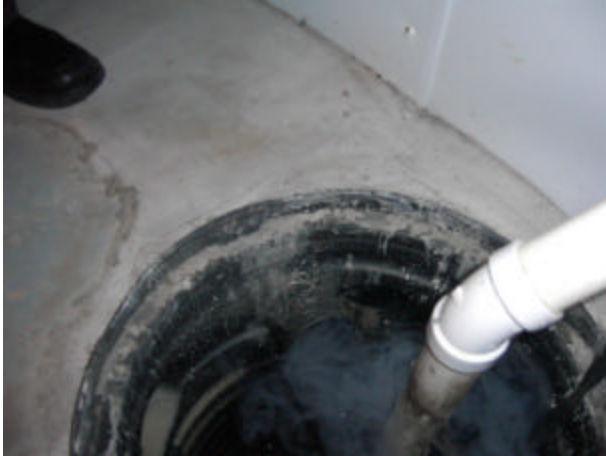
The two basement sump pumps were very active. Both sump pump covers were not 100% sealed.

- 2. The HVAC humidifier when on can cause condensation conditions. It is recommended not to use this unit unless absolute necessary.**
- 3. The sump pump covers are not sealed. Grains of moisture are leaving these sump pumps and contributing to the basement condensation conditions. Sealing both sump pump covers is recommended.**

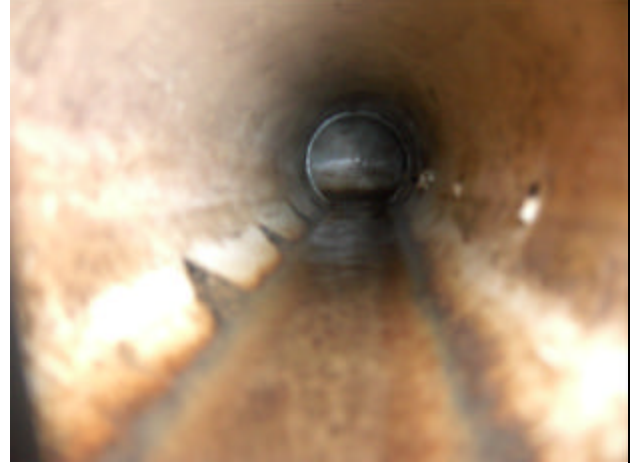
The active sump pump pipes were perforated and full of water. This is an interstitial pipe photograph of the drainpipes that lead to one of the sump pumps. The point is that these sump pumps communicate with the wet ground. If the tops of the sump pumps are not sealed, this wet ground communicates the inside of the home.

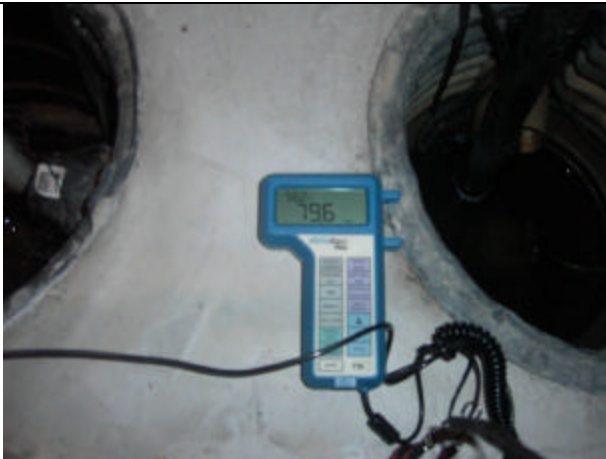
The humidity in the sump pump pits and drainpipes was 80%. This level of humidity is excessive.

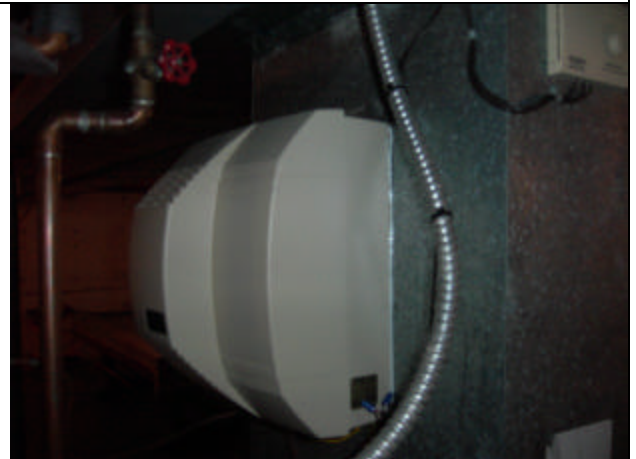
The humidifier on the HVAC system was a large moisture generator. It is our opinion, that these units when operating are the number one cause of condensation problems in homes.

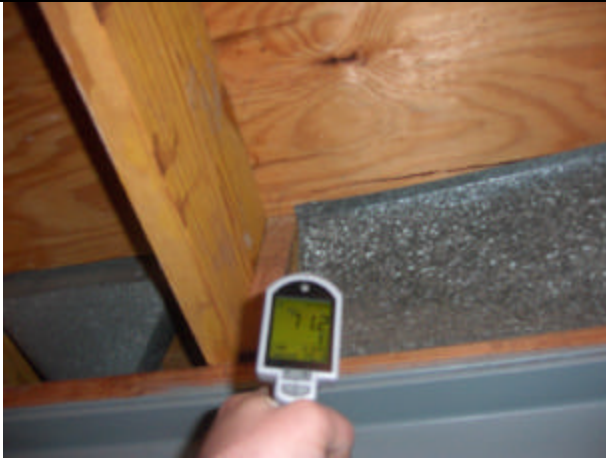
The cold air returns were not sealed with furnace tape. Everytime the HVAC system turns on; the cold air returns suck the basement. These cold returns also suck the humid air out of the sump pump pits.

- 4. The HVAC cold air return is infiltrating some basement air causing a depressurization condition. Sealing the cold air return with furnace tape is recommended. Balancing HVAC systems are also good protocol.**

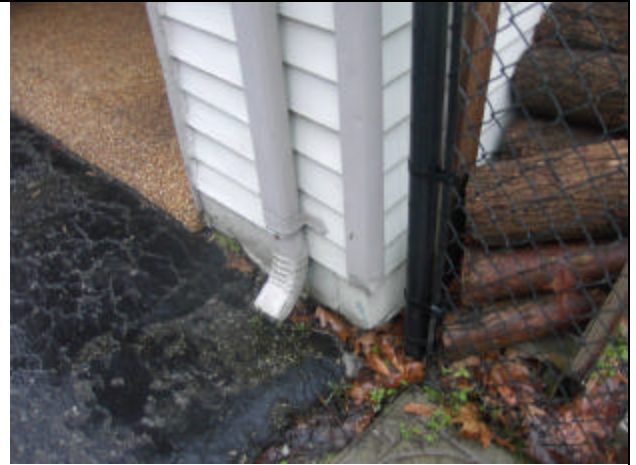
Exterior drainage needs to be better controlled.

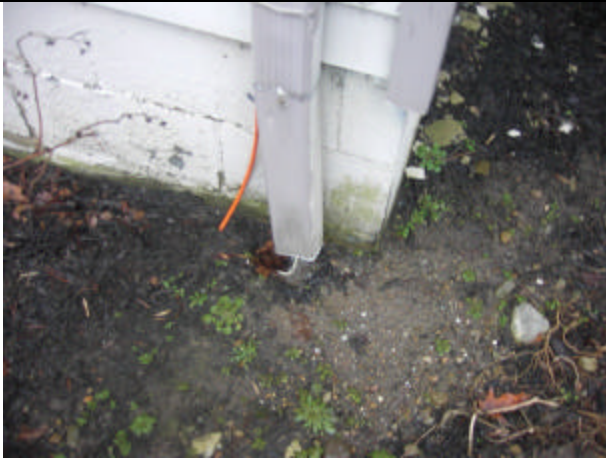
Exterior drainage needs to be better controlled. This downspout is not connected

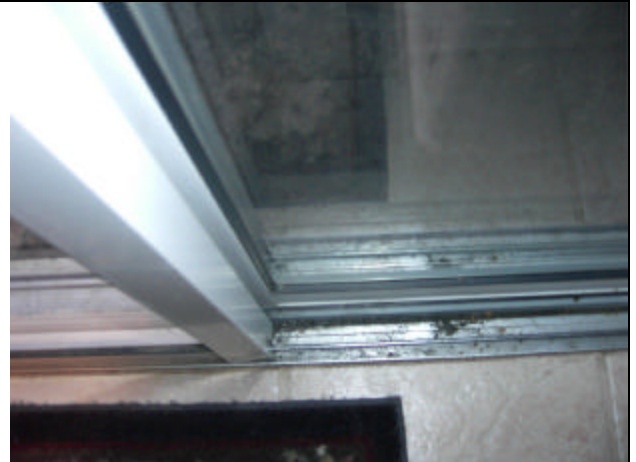
The interior metal doorframes show obvious condensation stains from past events. This home has had high humidity for many years.

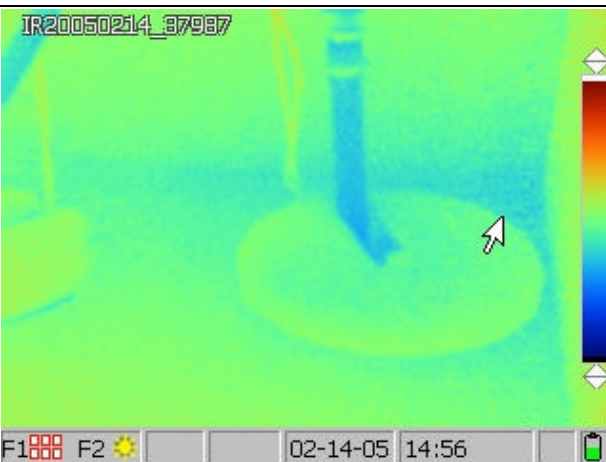
Infrared image shows that this sump pump is very active.

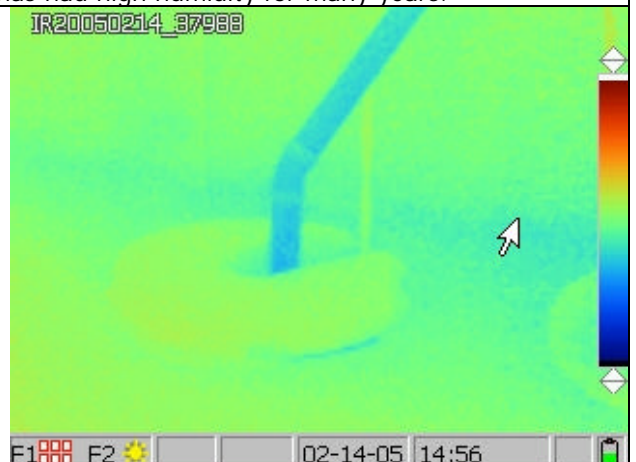
Infrared image shows that this sump pump is very active.
