Exterior Lead Clearance Test
10-18-13

On 10-11-13 the single (west unit side-side) family residential home located at **XXXX** Baltic Cleveland Ohio 44102, **PASSED** the exterior lead clearance test.

Scope of work: We were instructed to perform an "exterior and interior lead clearance testing of the xxxx Baltic Cleveland Ohio 44102. This was a side-by-side home and the west side was tested.

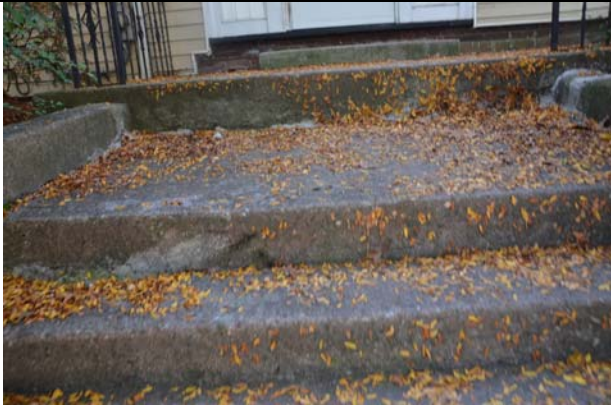
No peeling paint on exterior pavements.

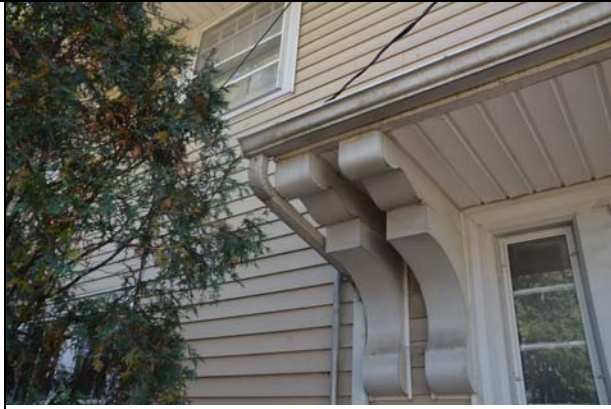
No peeling paint on exterior trim

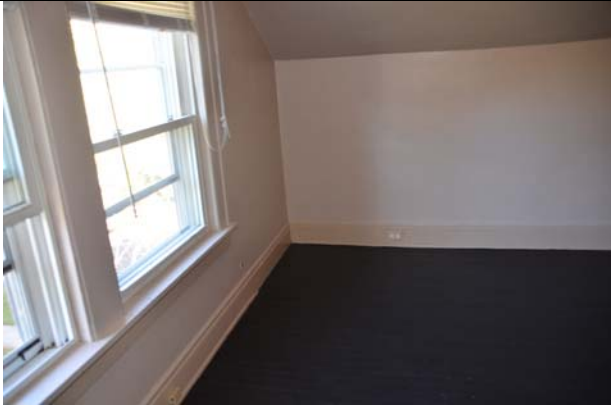
No peeling paint on interior baseboard, floors, walls, and ceilings.

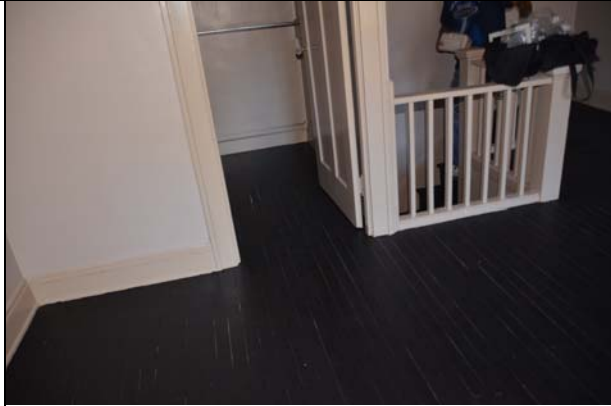
No peeling paint on stair rails or trims.

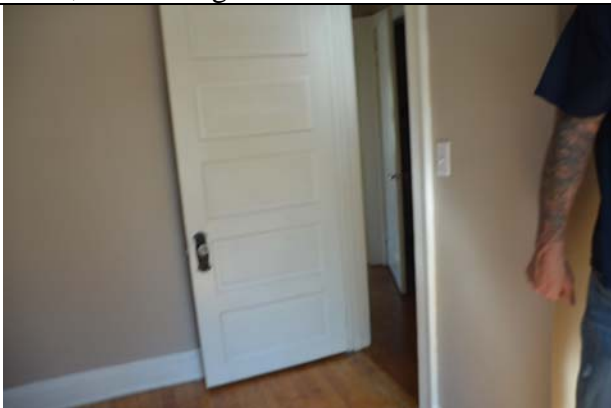
No peeling paint on doors, jambs, and trim.

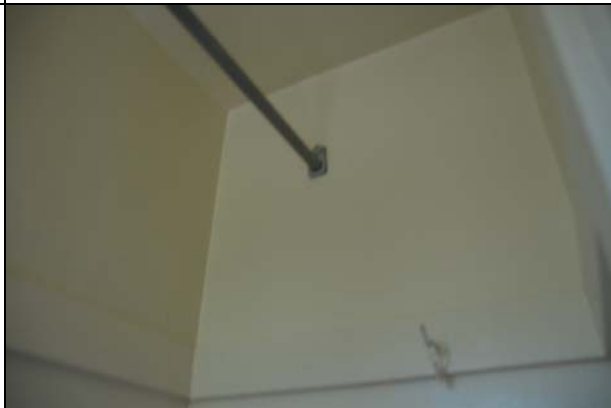
No peeling paint in closets.

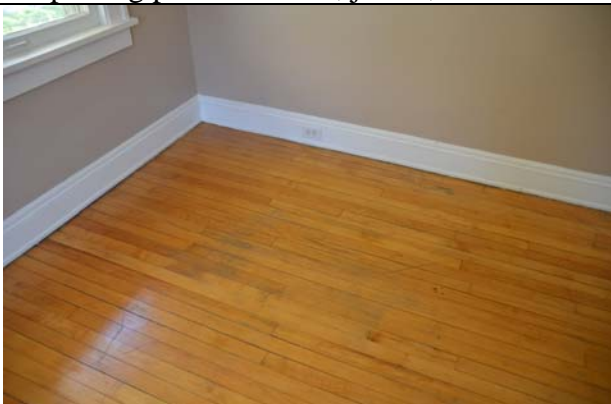
No peeling paint on wood floors.

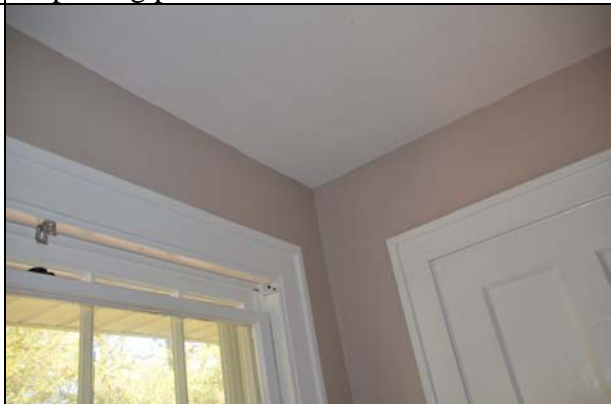
No peeling paint on windows, trim, sills, and troughs.

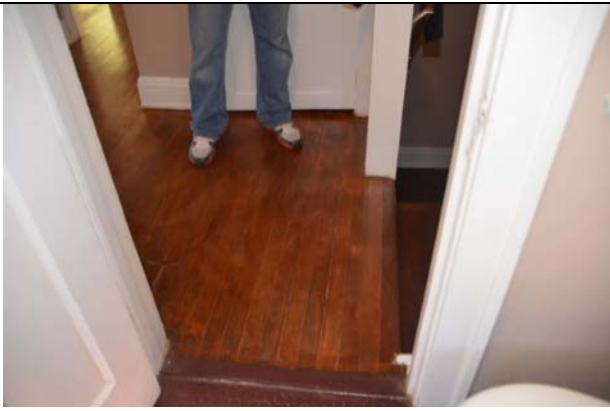
No peeling paint in halls and on steps.

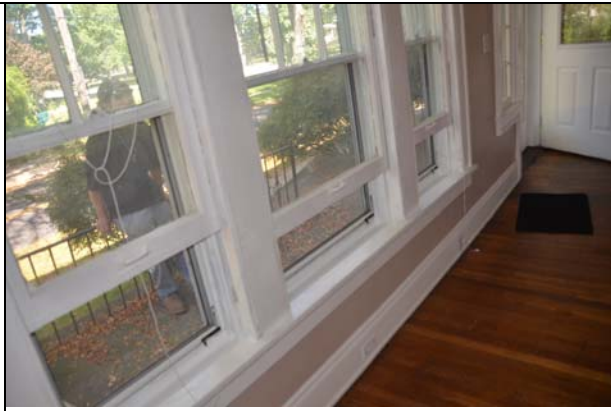
No peeling paint on windows, hardware, jams, and sashes.

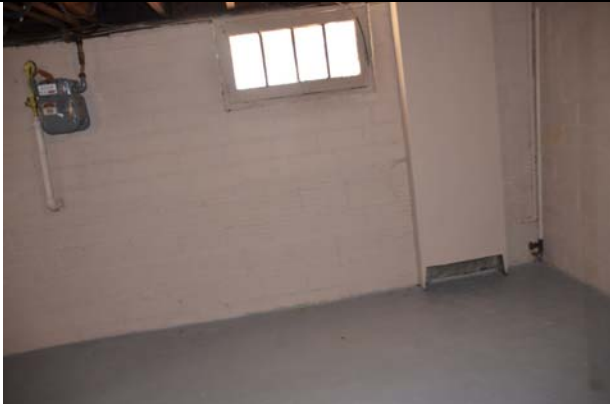
No peeling paint on basemetn walls, floors, mechanical ceilings, trim, or ducts.

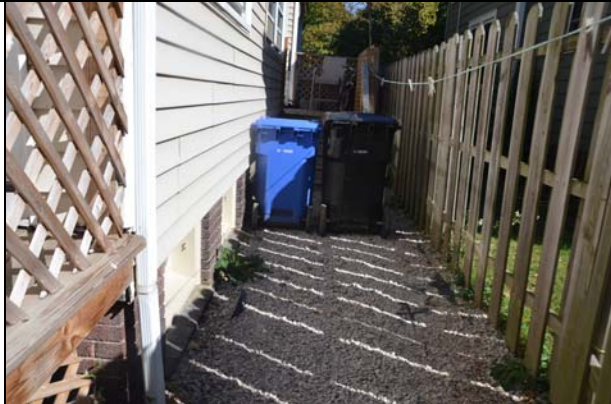
No peeling paint on fences. Most walks were concrete or gravel with no exposed soil

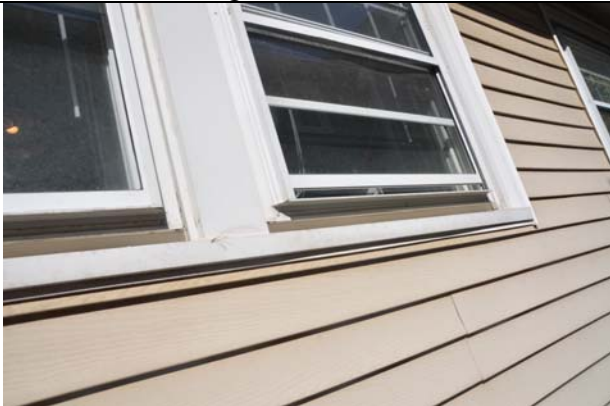
No peeling paint on exterior windows.

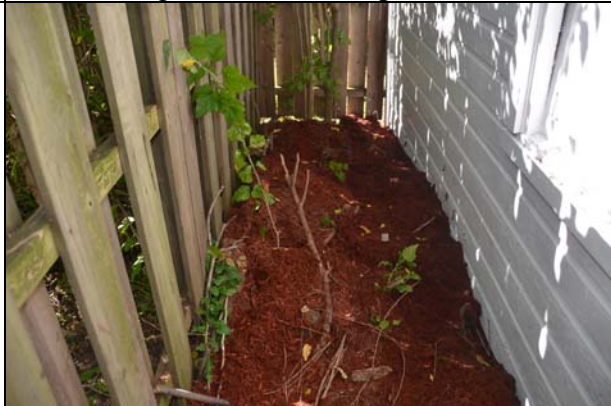
No exposed soil around garage and house drip line.

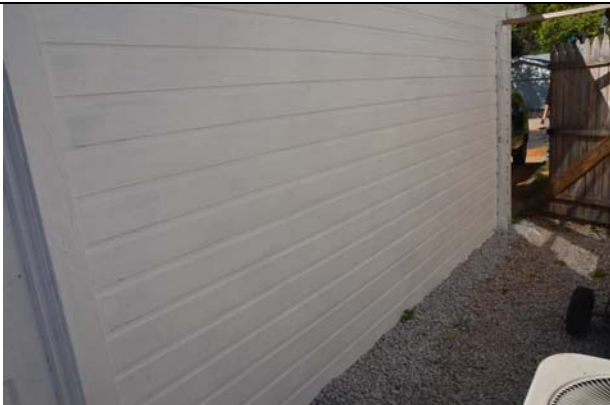
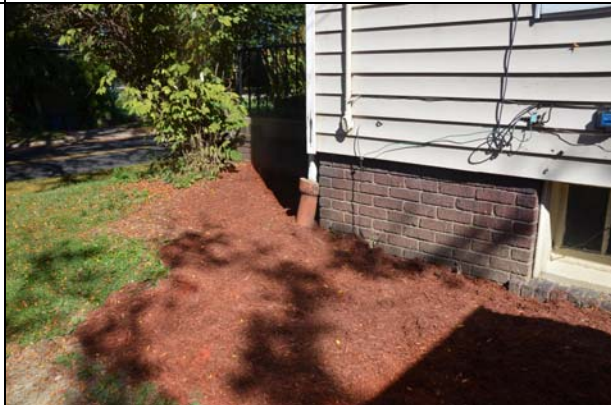
No peeling paint on garage. No exposed soil around garage.

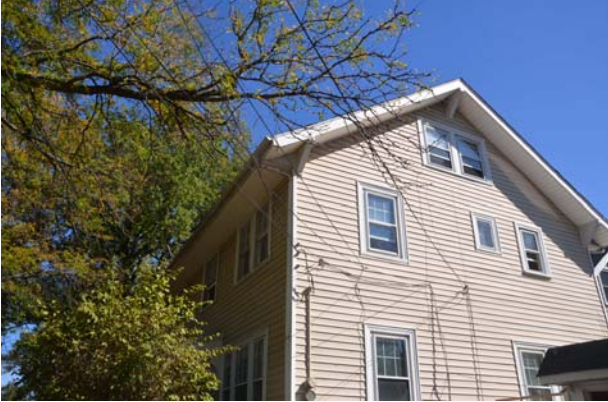
No peeling paint on exterior siding, soffits, fascia, gutter boards, downspouts, or other.

No exposed soil on property. Some front areas had autumn leaves.

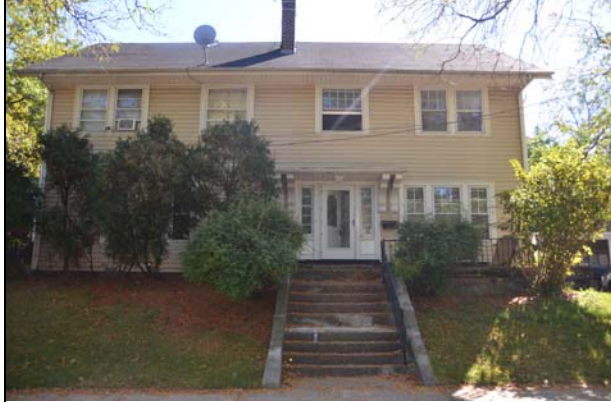
No peeling paint or dust on concrete steps or walks.

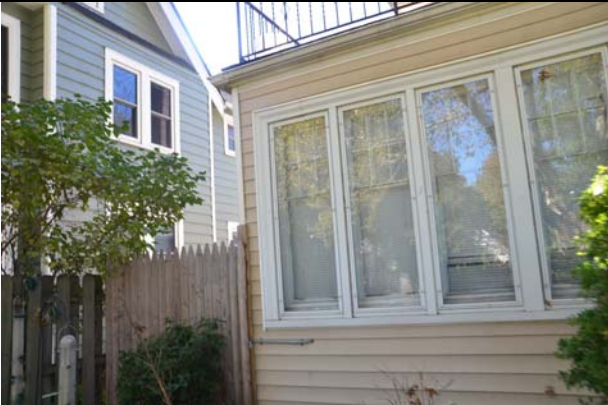
No peeling paint on exterior siding, windows, or trim.

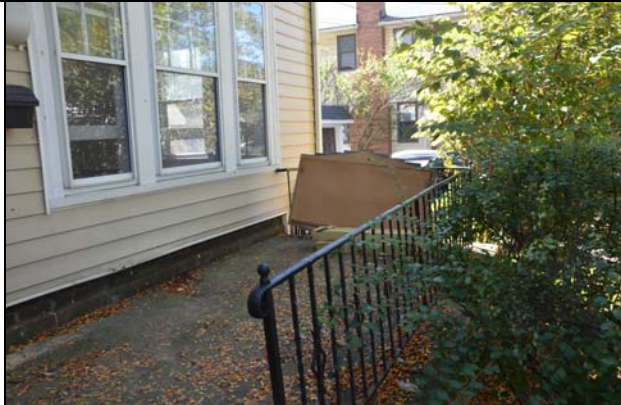
No peeling paint on exterior rails.

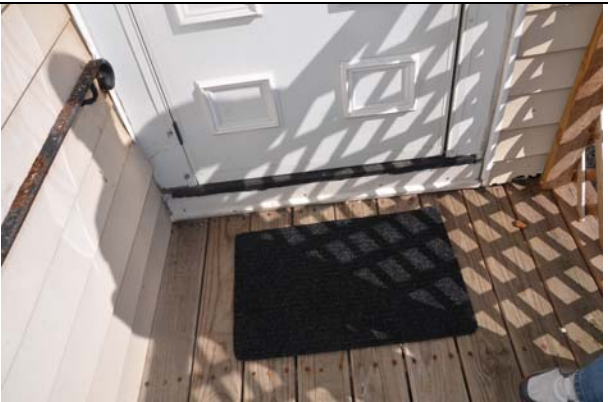
No peeling paint on front porch.

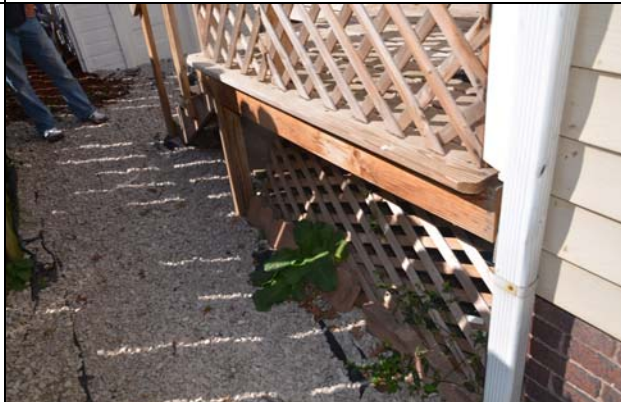
No peeling paint on back porch.
