To: XXXXXXXXXXXXXXXX

Job: XXXXXXXXXXXXXXXX

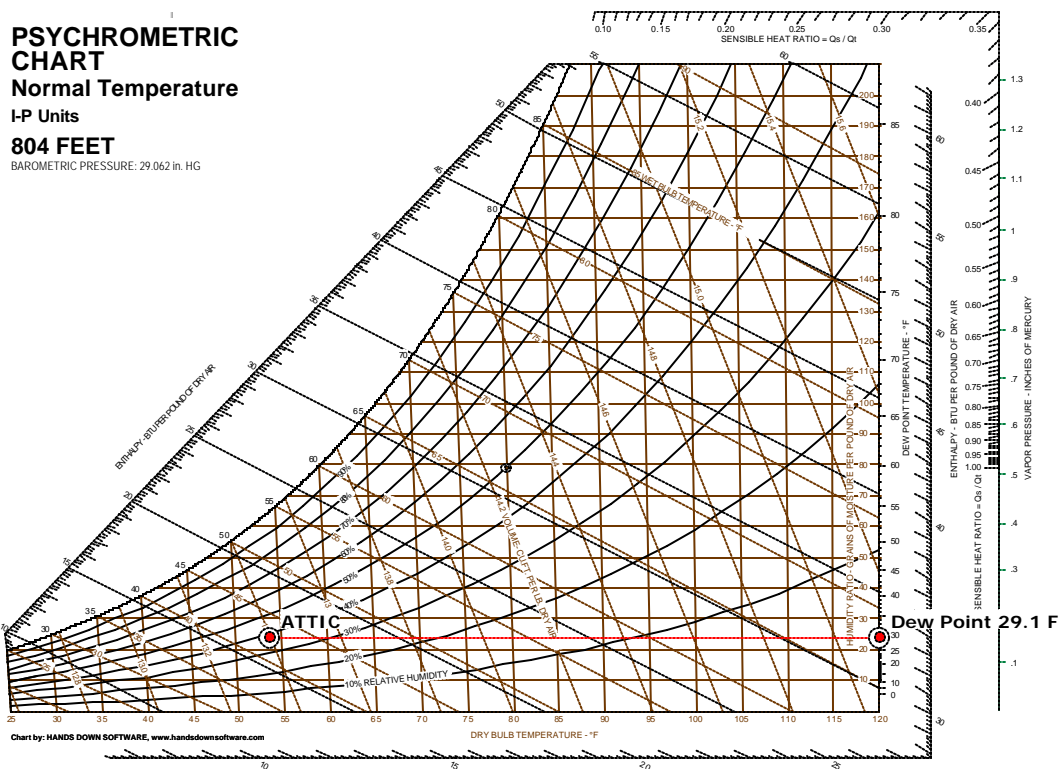
The above mathematical representation depicts that during our inspection, the dew point³ for the above attic condition was 29.1 F. The attic surface temperatures are not below this dew point. The conclusion that can be drawn from these calculations is the present ice dams and attic mold conditions **are not** caused by the occupants living conditions, but rather from the building anatomy poor roof ventilation, and a poor roofing installation.

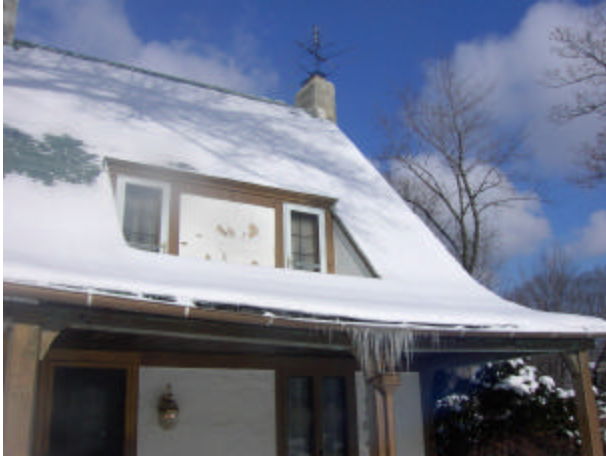
Ice dams are caused by poor ventilation. Damage now exists to porch, shingles, gutters, trim, and other siding material.

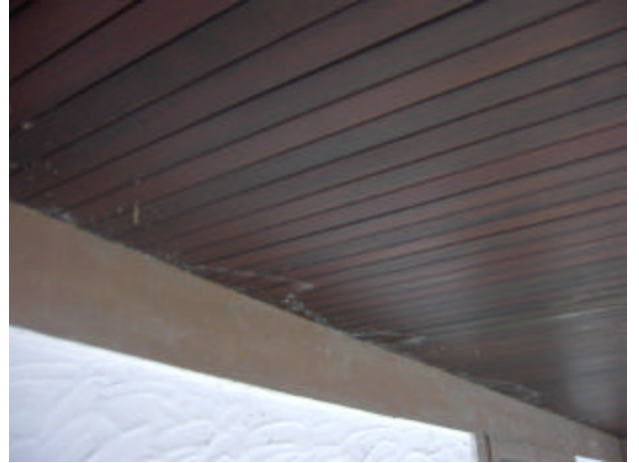
Ice dams have caused significant damage to the entire front porch. Stains still exist from the melting process.

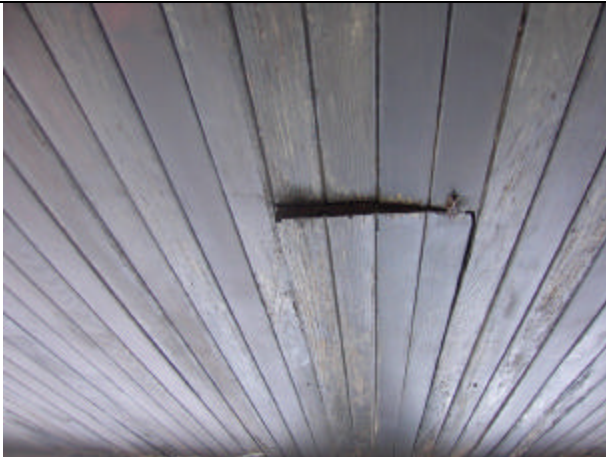
Front porch is damaged by water, mold, and ice.

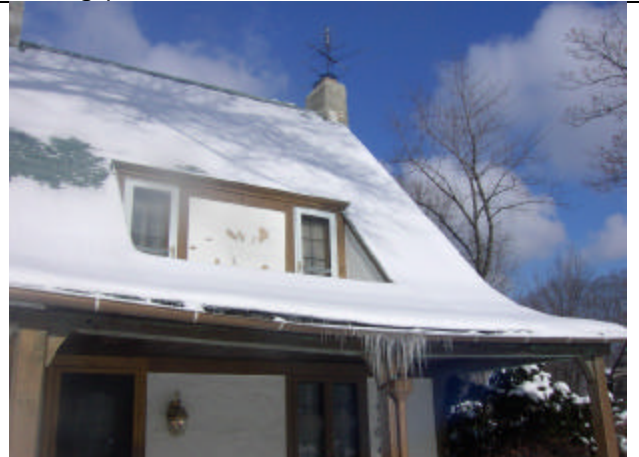
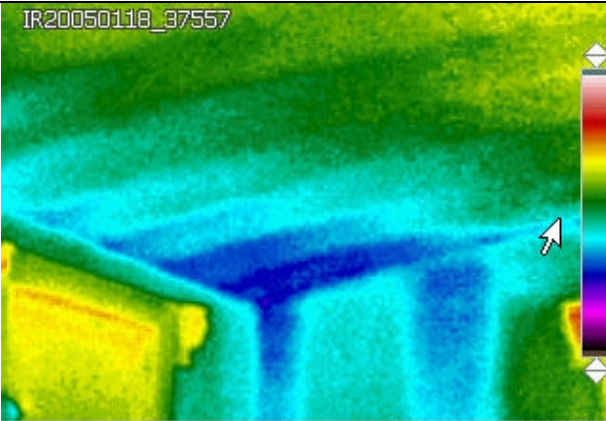
Ice dams have caused major damage to the living room ceiling. Infrared shows moisture within the older plaster.

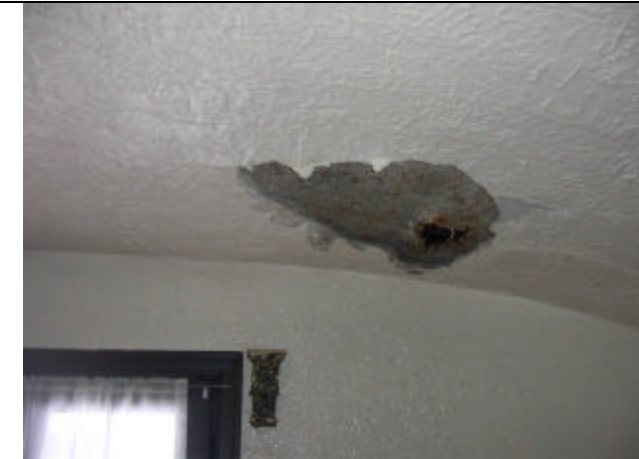
Ice dams have caused major damage to the living room ceiling. Ice dams have caused the living room ceiling to fail. This is the same infrared image the is shown adjacent.

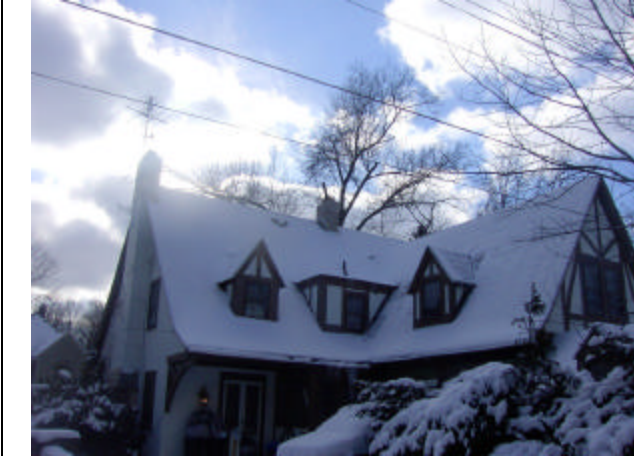
The last roofer changed the homes roofing system. The original roof was made of tile. The new roof is now shingle. The roofer should know if you change the roof anatomy, you must take all variables into consideration. This roof does not have enough ventilation for the newer asphalt shingles.

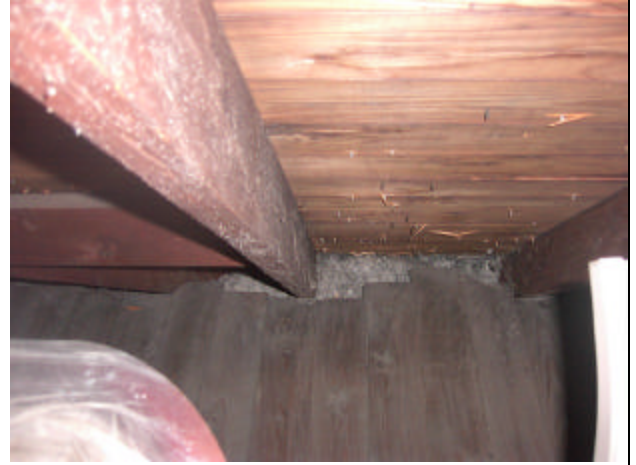
Lack of roofing ventilation does not allow for the proper attic ventilation. This condition has caused fungal reservoirs to develop and amplify. The old removed tile roof had more ventilation due to the large gaps between tile members and roof sheathing.

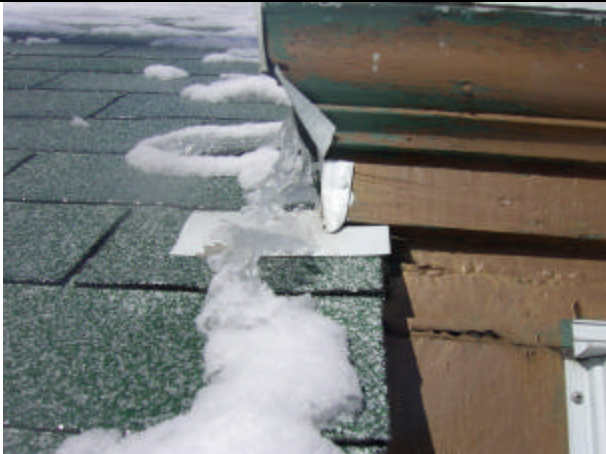
The roofing installation is substandard. Flashing installation is substandard.

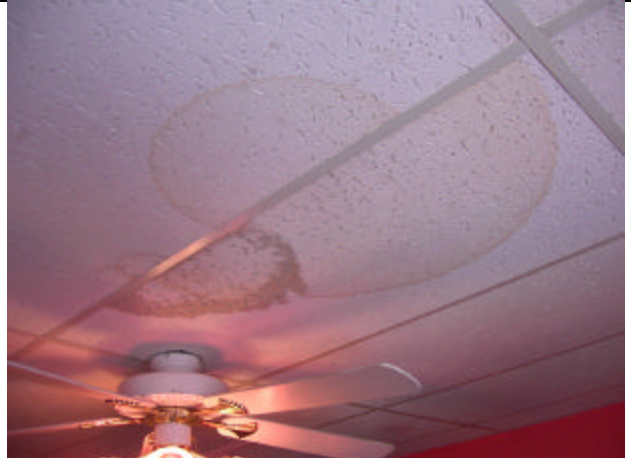
Leaks have now caused damage to interior plaster and drop ceilings.

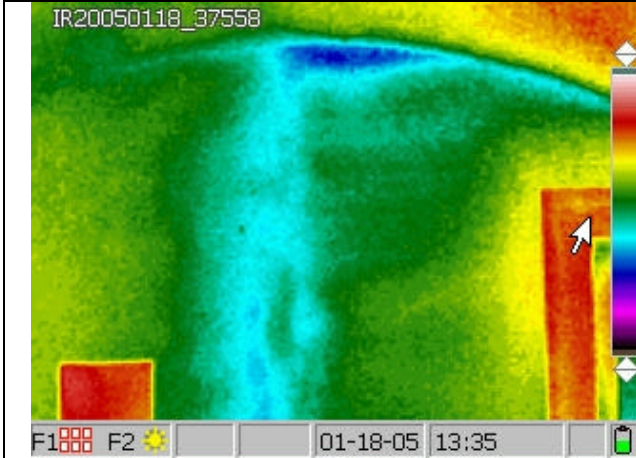
Ice dams are now melting and causing interstitial moisture. The blue color in this infrared image is water trapped inside of the exterior wall from melting ice.

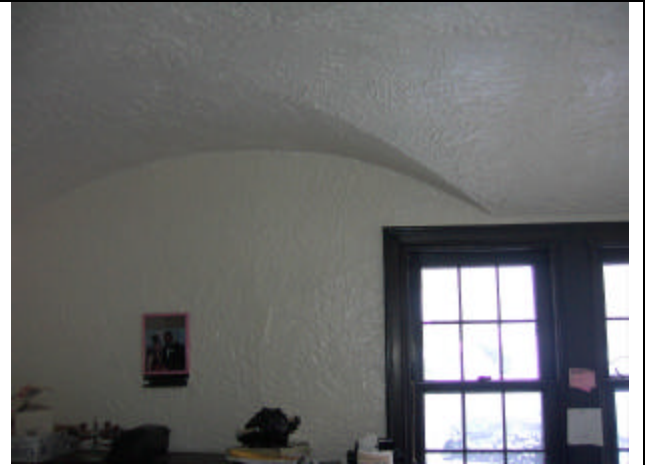
This image looks good. But if you look at the adjacent infrared image, you will see that water is running down the inside of this wall from the melting exterior ice dam.

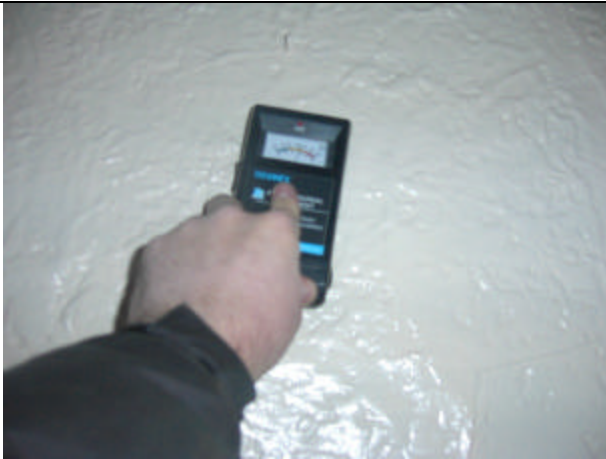
The moisture meter shows that excessive moisture exists within this wall. All walls that were wet should be removed and replaced.

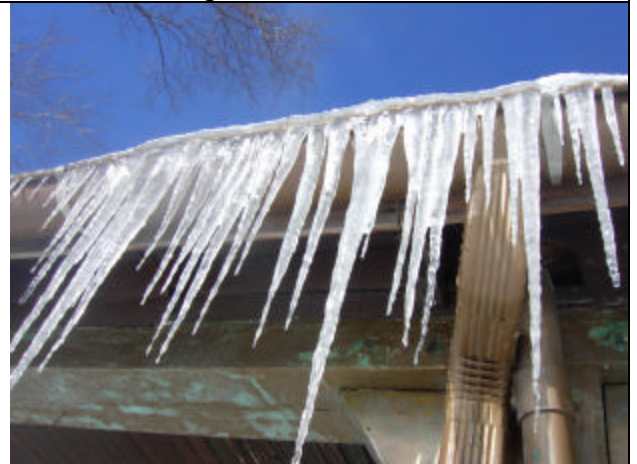
The home still has many ice dams. The roofer contractor changed the anatomy of this home. This contractor should have incorporated proper ventilation to this roofing system.

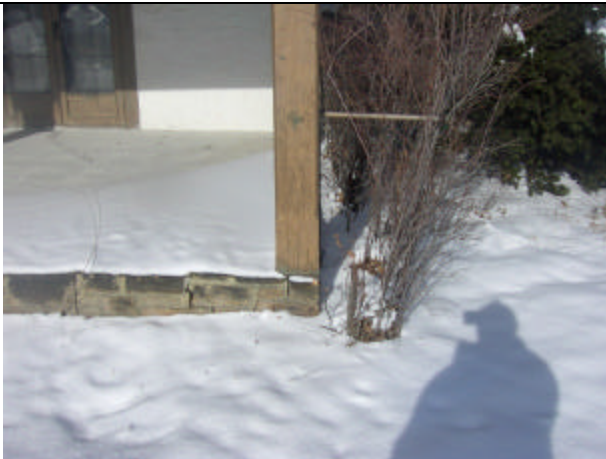
The front porch has foundation structural

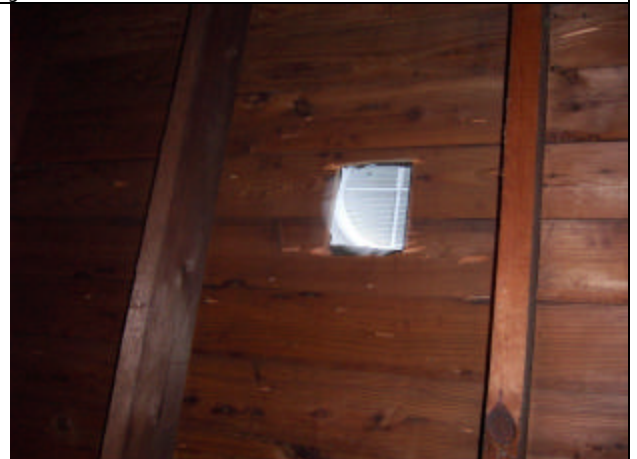
The few attic vents the contractor did install,

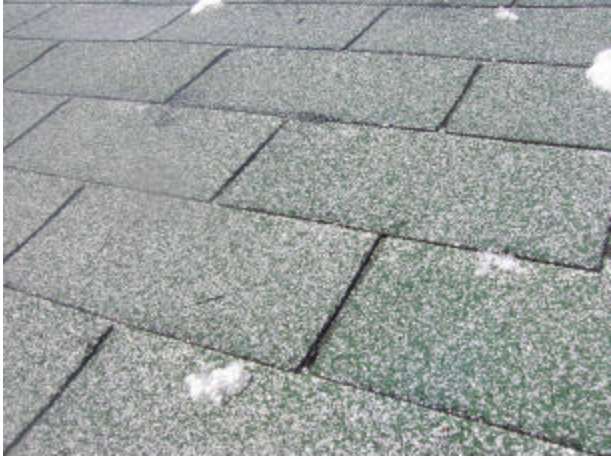
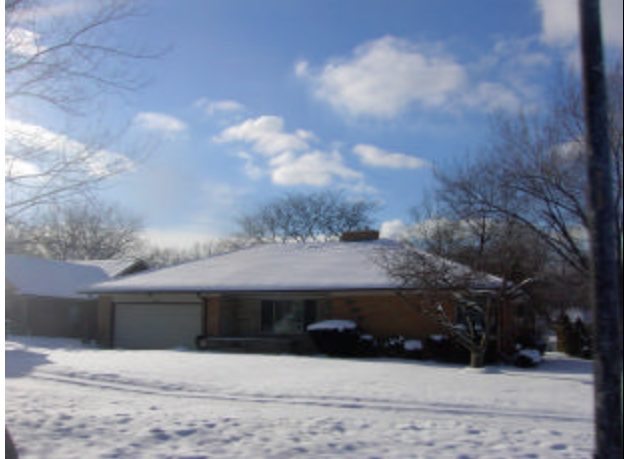
<p>The new roofing membrane has some surface damaged from foot traffic and possible roofing installation methods</p>	<p>Other homes in your area do not have ice dams. This is a home one block away.</p>

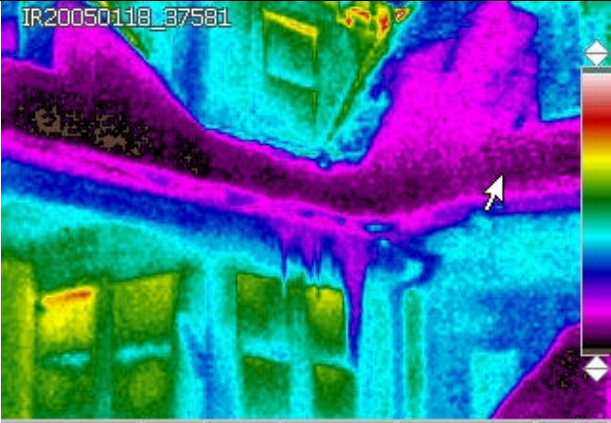
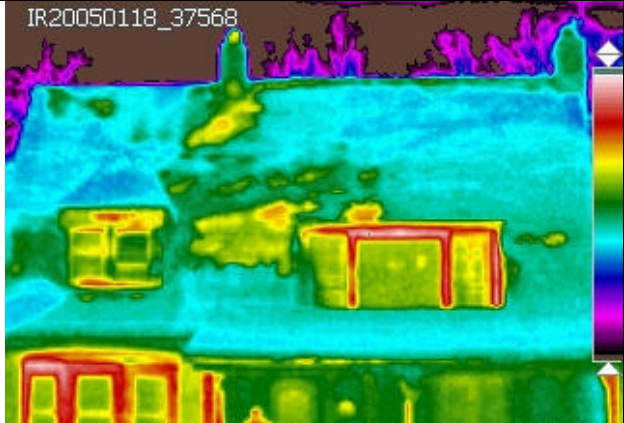
<p>The ice dam can be seen hiding under the roof snow on the north side. The purple color is ice.</p>	<p>Uneven snowmelt occurs due to this buildings anatomy. This condition is allowing for excessive ice dams to form. The roofer is a professional and should have warned you of these potential occurrences.</p>
