Re: Mold and water dripping in attic

From: Marko E. Vovk  
Forensic Moisture Investigator  
Ambassador Construction Consultants Inc.

Date: 1-28-04 Cold Snow Cover / 24.3 F / 35.9 RH / Dew point 30.0  
Inspection time 12:30 PM – 2:30 PM

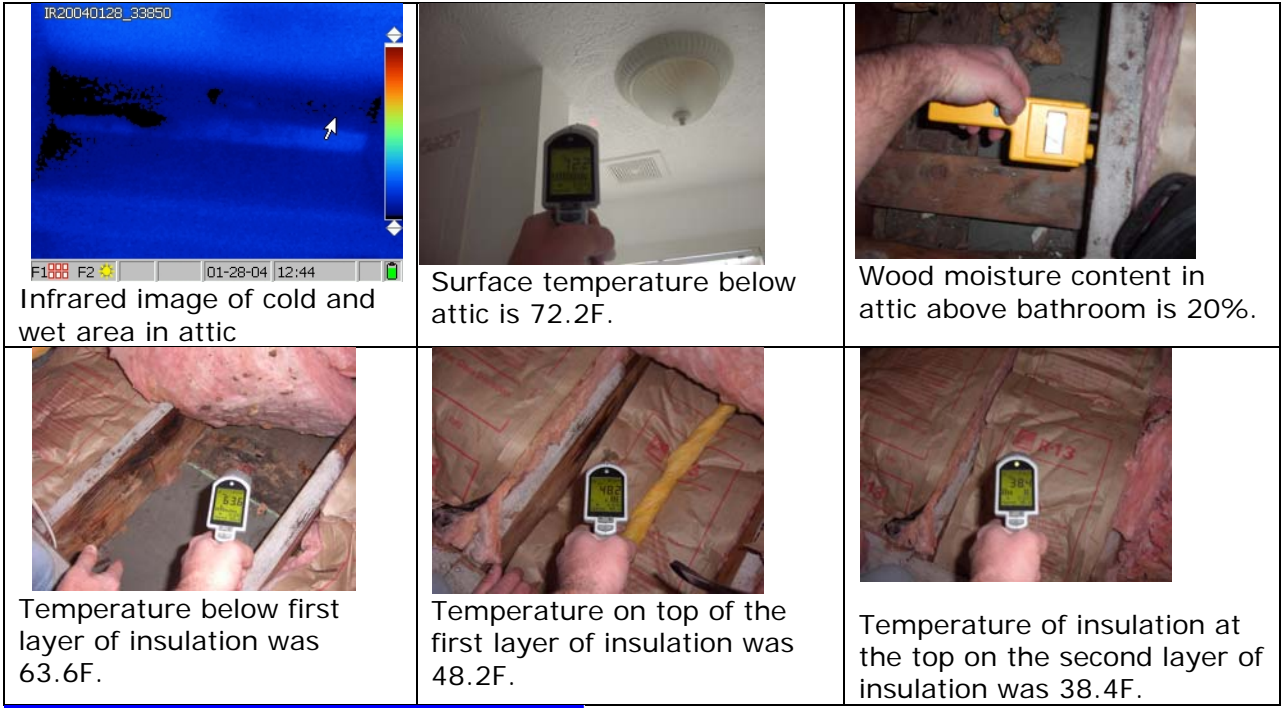
**Wet insulation math above bathroom**

The bathroom below this wet insulation area had indoor air conditions initially at 71.8F room temperature and 39.5 relative humidity. The actual dew point was found to be from the above chart to be 45.9F. We also plotted the attic conditions and

found the dew point to be 32.6 F. This means that that moisture is condensing somewhere between these two dew points. We measured the temperature of the different layers of insulation using an infrared device. The temperature was found to be in this range. This is why the insulation is wet between the first and second layers of insulation above the bathroom. It was inevitable that water accumulated above this bathroom. You should not use two layers of batten insulation because moisture will be trapped. It is a double vapor barrier and moisture will be trapped. Sometimes, if you do not have this vapor barrier moisture can move freely through vapor diffusion and exist. However, in this home, moisture does not completely exit. It stops at the attic sheathing and forms another dew point. All or most attic sheathing was found to be below the calculated 32.6 F dew point. Attic surface temperatures were found to be 31, 36.2, 30.6, and 31.6. This condensation is causing desirable conditions from microbial amplification.
