Job: Ground Zero Location

Building Science Section

PHOTOGRAPHIC ESSAY

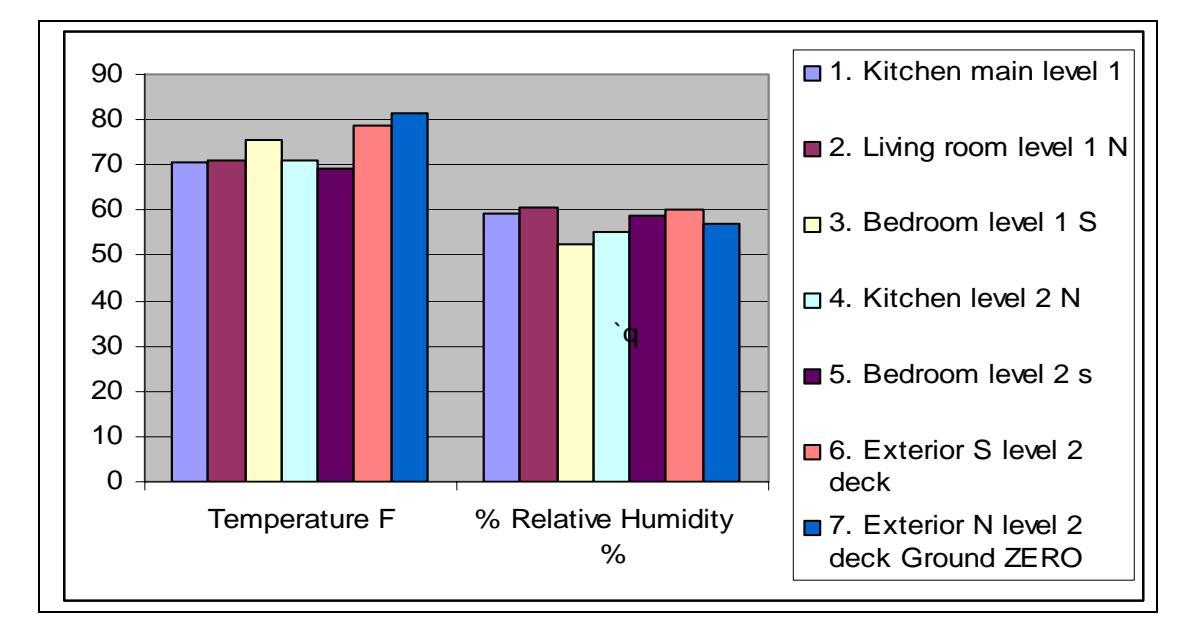
The following are field data from moisture and humidity mapping.

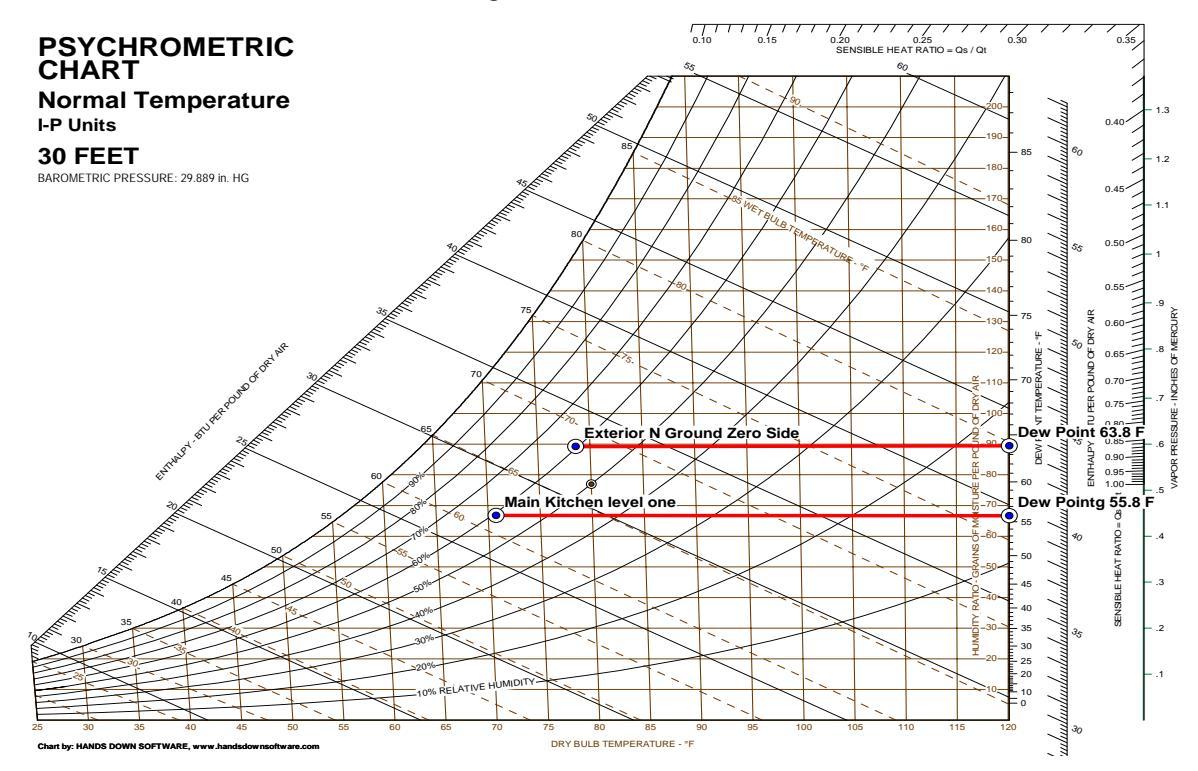
Below we plotted the coolest room. Condensation will occur in cool rooms first. Level one main kitchen and small dining area.

The above graph depicts that during our inspection, the dew point¹ for the above kitchen area condition was 55.8 F. On the day of inspection all condominium surface temperatures were all significantly above this dew point. Dew point temperature and moisture are both necessary for microbial amplification. When indoor moisture generators produce excessive moisture high indoor humidity, condensation, fungal amplification, bio-growth, insects, mites, not optimal indoor air quality can be the outcome.

When comparing the exterior air to the interior air, the interior air had slightly more grains of moisture. The interior had .0743 lbs/cuft of water and the exterior had .0731 lbs/cuft of water. The AC unit was on. The AC unit acts like a dehumidifier. When AC units are on, they extract moisture from the air. Running the AC or a dehumidifier will help control moisture in the air. A spare dehumidifier will help control humidity during peak humid times.

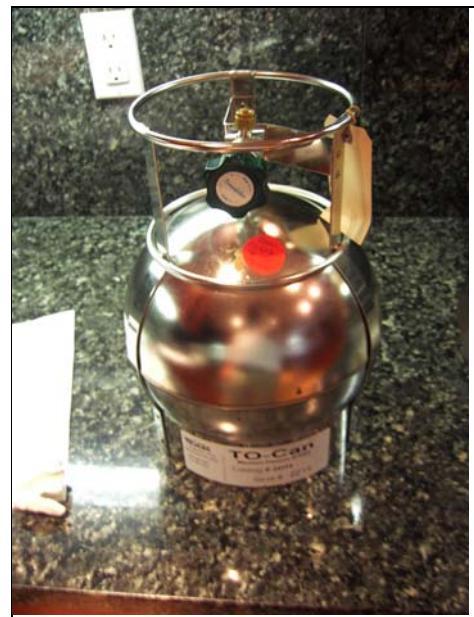
Limited VOC testing was done. One onehour sample was drawn and sent the laboratory for analysis. Please refer to other sections of this report.

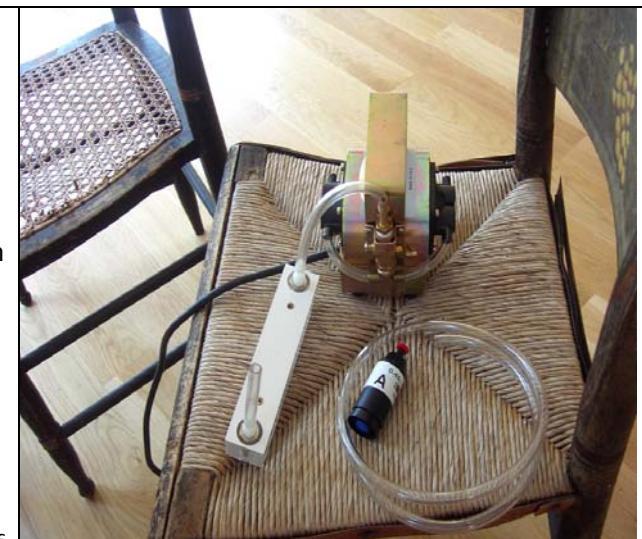
Due to the 911 potential dusts contamination, the inspector took two two-hour personal air monitor tests samples for asbestos content. These samples were taken to the laboratory. Please refer to other section of this report.

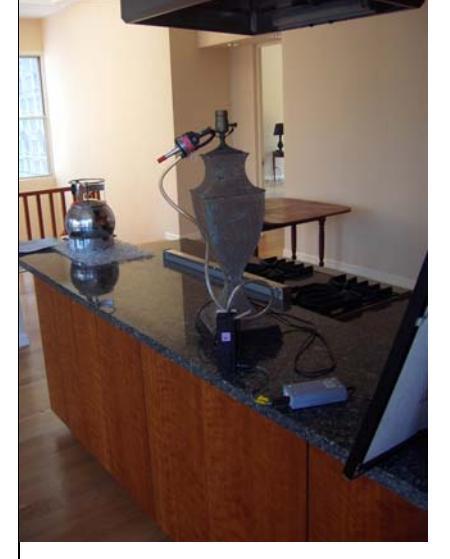
One sample for silica dust was taken from the second level. This was a four-hour draw that was sent to the laboratory. Please refer to other sections of this report.

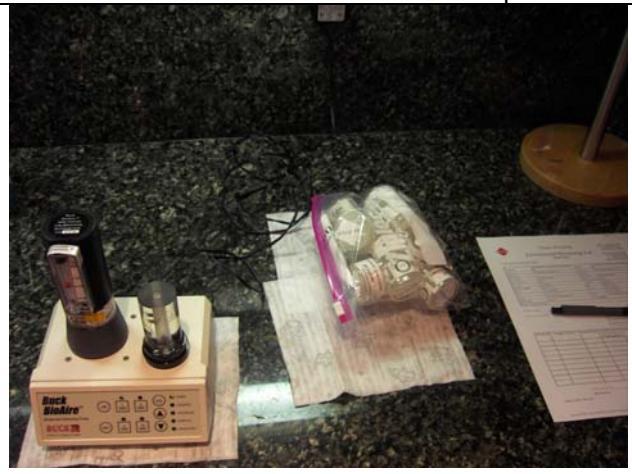
Numerous Air-O-Cell samples were taken for non-viable fungi, glass fibers, insect fragments, and pollen and skin fragments. These samples were sent to the laboratory for analysis. Please refer to other sections of this report.

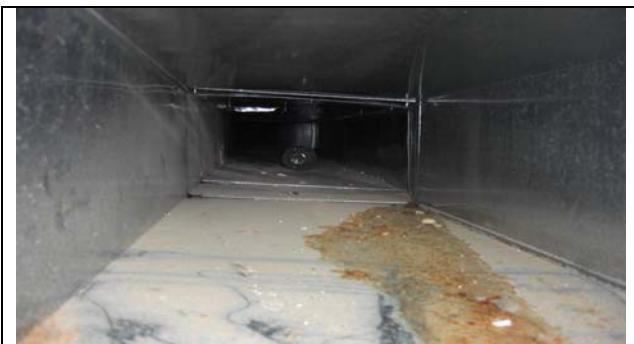
The HVAC ductwork was dirty. The supply ductwork is full of dust, sticky stuff and debris. Professional cleaning is required. At this time, it is assumed that other duct systems in this building are dirty as well. The building management should provide all necessary information.

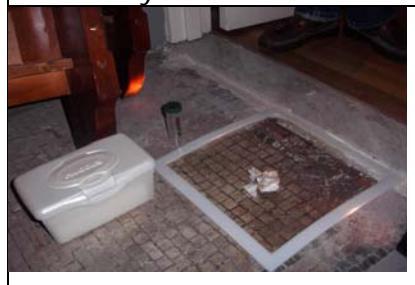
The back stairwell was contaminated with dust. This hall stairwell communicates with the penthouse

condominium. It is possible the 911 dust exists in this stairwell. The inspector took one sample for full particle identification. This sample was sent to the laboratory for analysis.

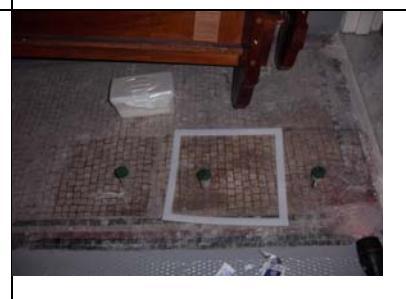
The back stairwell was contaminated with dust. This stairwell communicates with the penthouse

condominium. It is possible that the 911 dust exists in this stairwell. The inspector took one personal dust sample for asbestos testing. The asbestos sample results should not be construed as conclusive. These samples were taken for personal air monitoring purposes. This sample was sent to the laboratory.

The result from this back stair floor wipe sample was positive for Chrysotile asbestos. The concentrations detected were 46400 str/cm2. Any asbestos at any level is not good. This EMSL laboratory result is attached. Additional testing is recommended.

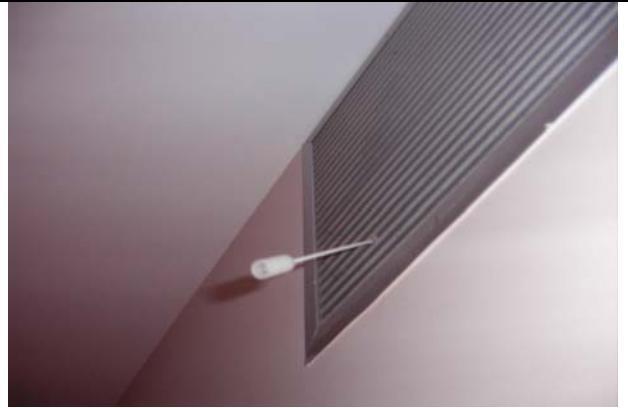
One cold air return grill on the first level was sampled for bulk fungal testing. This sample was sent to the laboratory. See other sections of this report.

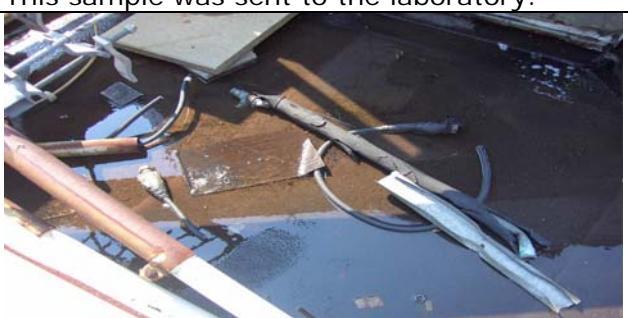
The AC unit on the rooftop has poor condensate discharge. Water is ponding on the roof. Roof debris is being saturated and providing an unsanitary environment. Roof water should not be permitted to pond. This condition needs to be properly controlled. The roof debris needs to be removed.

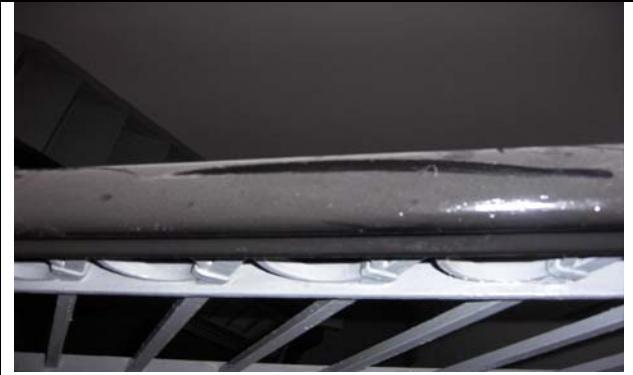
The back stairwell is dust contaminated.

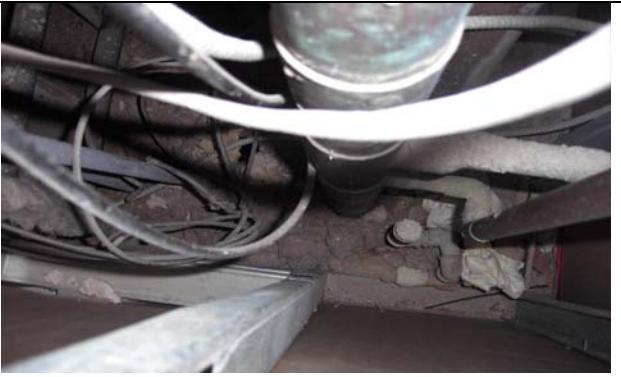
Dust and construction debris exists in some walls.

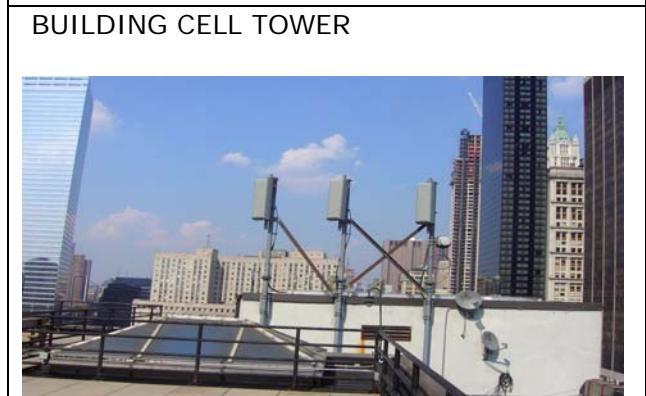
The cell tower is in direct plane of the outside patio areas. People on these exterior decks will be more exposed than people on the ground or inside the condominium unit.
